# State Highway 45 Post Construction Safe System Audit

Transport Choices – Barrett Road to Morley Street

Prepared for New Plymouth District Council  
Prepared by Beca Limited

23 July 2025

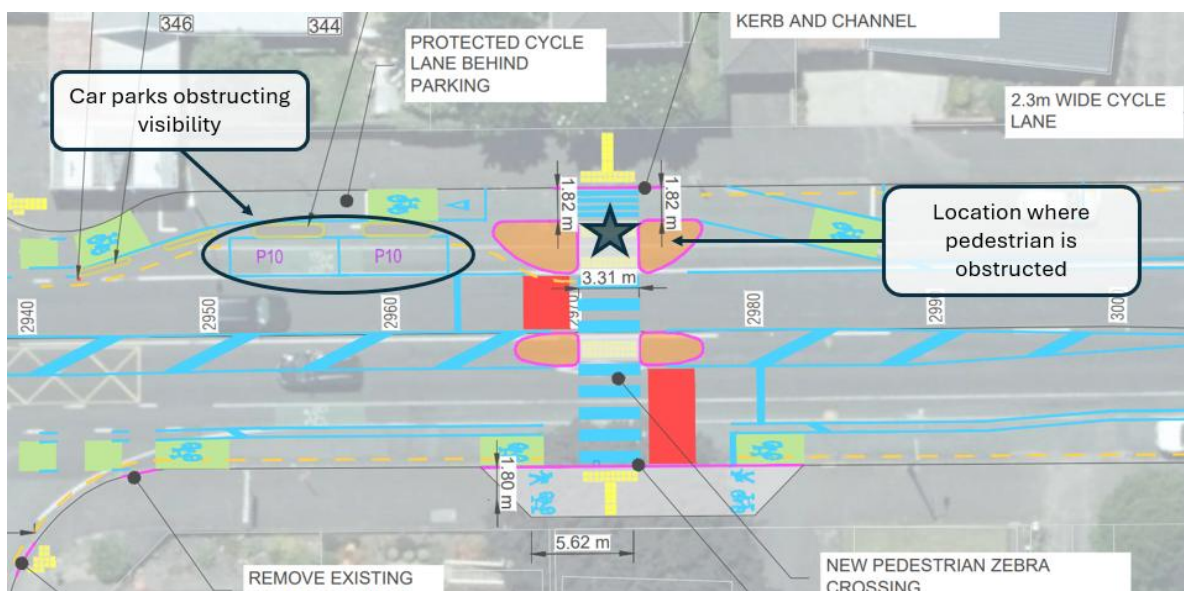
The two car parks located on the eastbound approach towards the new zebra crossing east of the SH45 / Belt Road intersection currently conceal pedestrians waiting to cross at the second stage (after crossing the cycle lane). This is particularly evident if both car parks are utilised, however, when only the westernmost (furthest back from the crossing) park is occupied, pedestrians are still concealed until the approaching vehicle is very close to the intersection. As such, the Approach Sight Distance (ASD) and Safe Stopping Distance (SSD) is reduced. This means that the approaching vehicle will likely not be able to see pedestrians crossing (or other hazards) in time to react safely and stop in time, colliding with the pedestrian. See **Figure 4-1** below.

Figure 4-1: Location on the pedestrian zebra crossing where users are concealed by the adjacent car parking

Limited visibility for both pedestrians waiting to cross and oncoming vehicles significantly increases the likelihood of a pedestrian vs vehicle collision. This risk is further heightened by the downhill approach with restricted sightlines, where eastbound vehicles are likely to travel at higher speeds, amplifying the potential severity of a pedestrian vs vehicle collision. During the morning and afternoon peak traffic times the crossing's proximity to various school's increase the volume of vulnerable road users, such as school children. As well as being smaller, children tend to have lower cognitive, sensory, and physical abilities than adults. This means they may not approach the crossing with caution and step out onto the crossing from behind the parked vehicles without establishing visual connection with the oncoming motorist. While pedestrians do have right of way, pedestrian zebra crossings rely on visual connection between users, as opposed to traffic signals where the decision is made for you. This increases the exposure, likelihood, and severity of pedestrian and vehicle type crashes.

- It is recommended that the two carparks located to the west of the zebra crossing are removed. This will increase the sight distances for both waiting pedestrians and eastbound on-coming traffic. (Primary treatment)

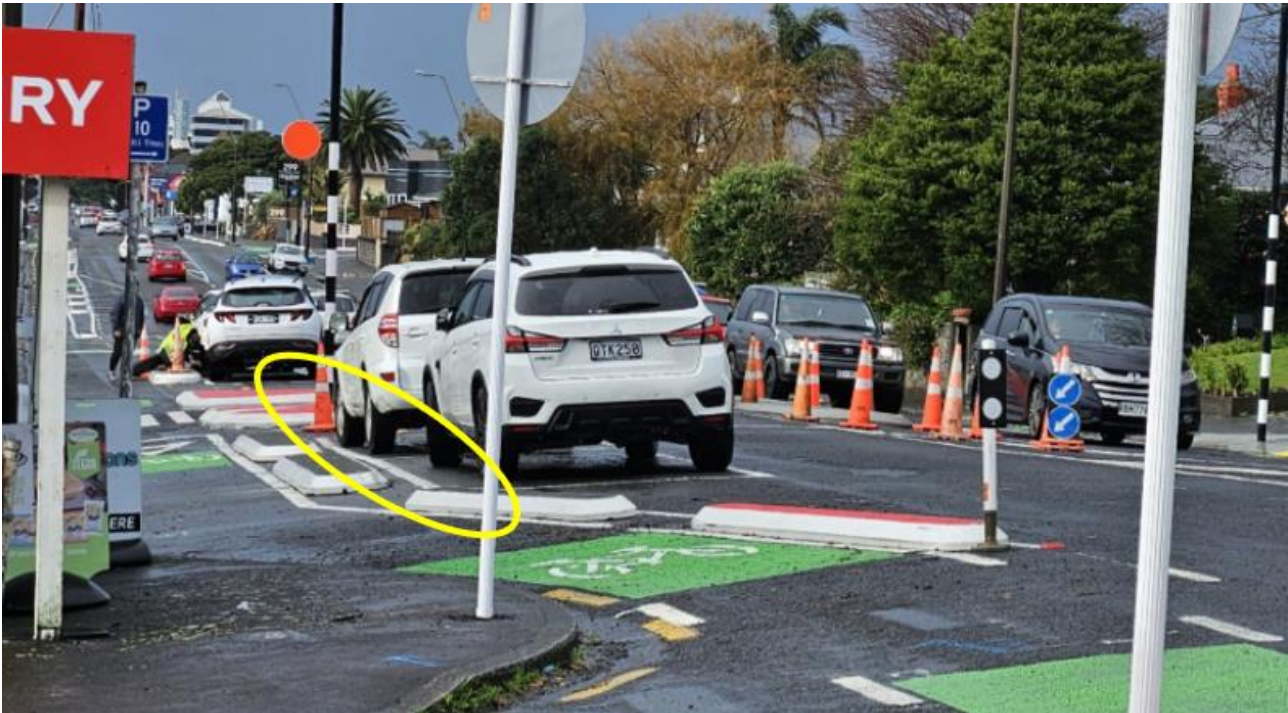
Additionally, vehicles using the carparks tend to shy away from the separator, resulting in drivers leaving a significant gap between themselves and separator. This is likely due to concerns around potential wheel damage due to the profile and proximity of the separators, as well as the approach entry angle. This parking behaviour further reduces the available approach sight distance and safe stopping distance. This is shown below in **Figure 4-2**.

Figure 4-2: Large space between the separator and parked vehicle (shown in yellow oval)

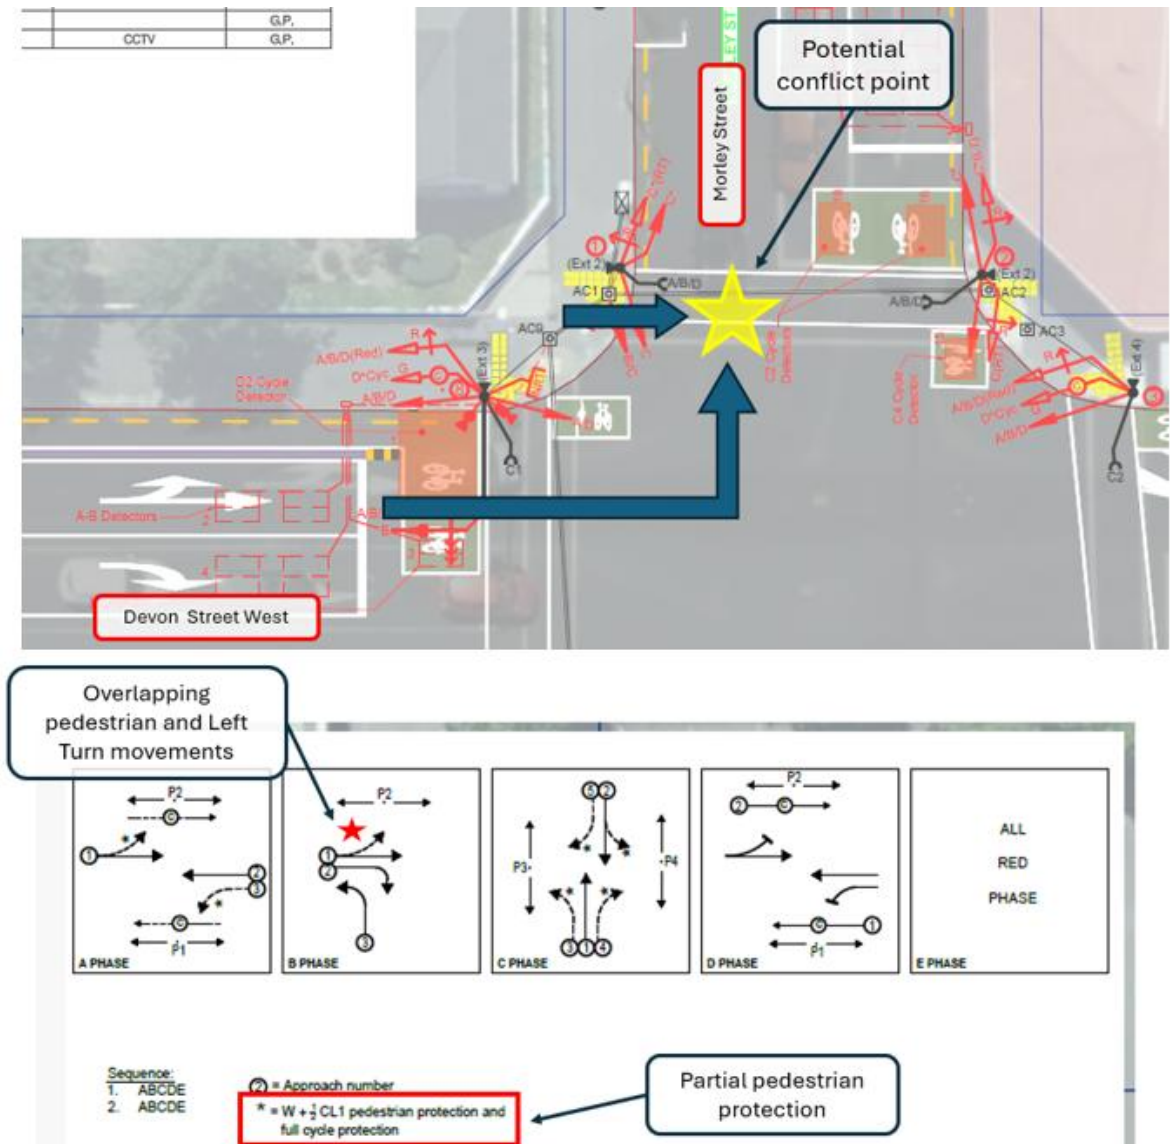
At the signalised intersection between Devon Street West / SH45 and Morley Street, in B-phase, pedestrians do not appear to be protected from left hand turning vehicles from Devon Street West / SH45 on to Morley Street. It is unclear if the pedestrian phase (P2) is being overlapped from A-phase to B-phase. This could increases the likelihood of pedestrian vs motor vehicle type crashes. See **Figure 4-3** below.

Vehicles turning left at this location are likely to be travelling less than 30 km/h which reduces the severity of these crash types.

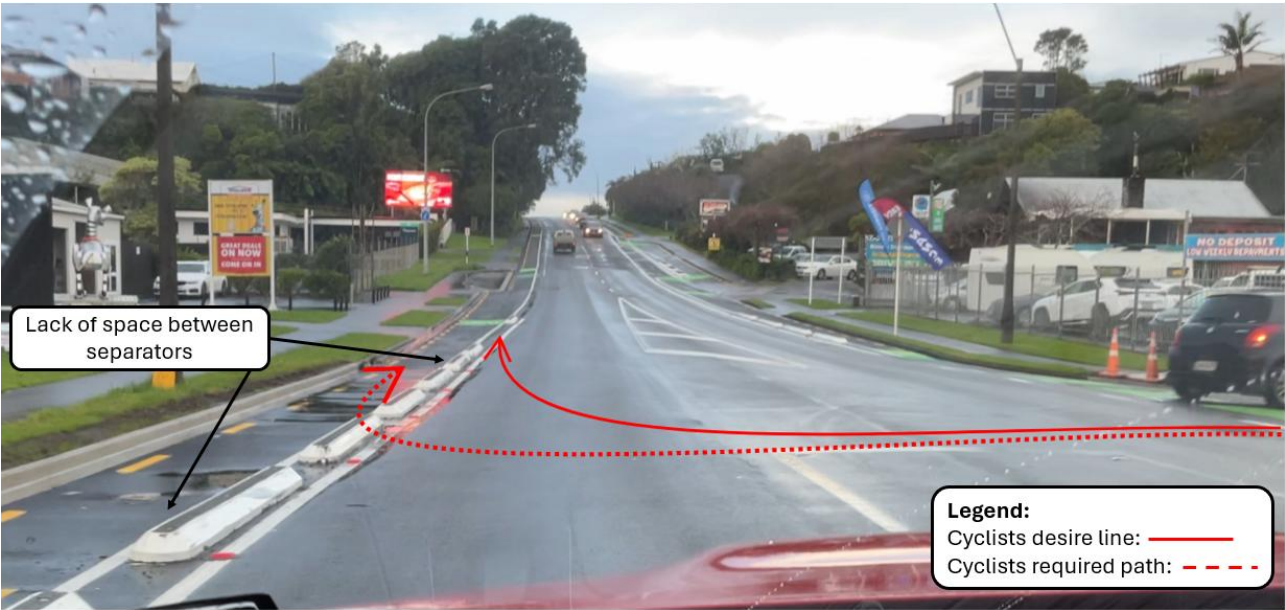
It was observed during the cycling site visit that cyclists turning right from Seaview Road onto SH45 / Devon Street West to head eastbound are confronted with a set of separators directly opposite the intersection. These separators are relatively close together leaving insufficient space between the separators to help the cyclists merge with the cycle lane, therefore, cyclists are temporarily ‘trapped’ in the live traffic lane before they can safely merge into the cycle lane north of the Seaview Road intersection.

The absence of a dedicated merging space for cyclists into the cycleway increases their risk of being struck by oncoming vehicles, potentially leading to side-swipe or right-angle crashes. The severity of such crashes is heightened due to the intersection's location at the bottom of a valley (sag curve), where vehicle speeds are typically higher due to the downhill slope. The lack of merging space for cyclists is shown below in **Figure 4-4**.

Figure 4-4: Lack of merging space at Seaview Road intersection

- It is recommend removing the separators directly opposite the intersection. This will create a gap that cyclists can use as a merging point, allowing them to safely cross into the cycle lane and exit the live traffic lane.

**Client Decision:** Agree with the Safety Audit Team recommendation. 1 Separator to be removed to allow for cyclists to enter the cycle lane. This should be sufficient to allow cyclists to enter the cycle lane, whilst minimising the risk of vehicles striking the end of the separator after the gap.

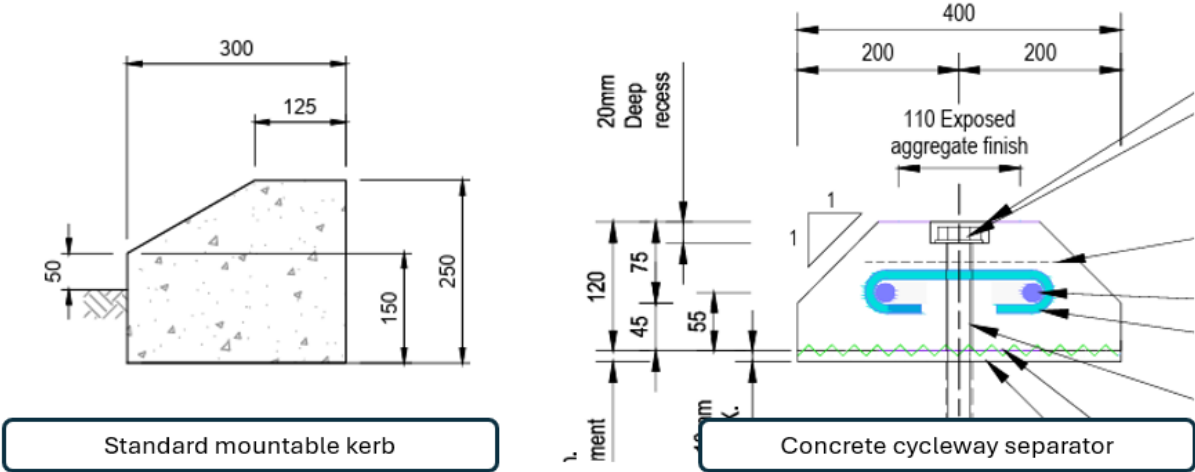
The profile for the separators suggests that they are non-mountable. While the height of the separators are in line with existing mountable kerb and channel found throughout the district, the gradient of the slope is steeper. The gradient of the slope on the separators is 1:1 as opposed to a standard mountable kerb which has a slope ratio of approximately 1:1.75. The differences between the concrete separators and a typical mountable kerb and channel is shown below in **Figure 4-5**.

Figure 4-5: Standard mountable kerb detail in comparison to the concrete cycleway separators installed along the corridor

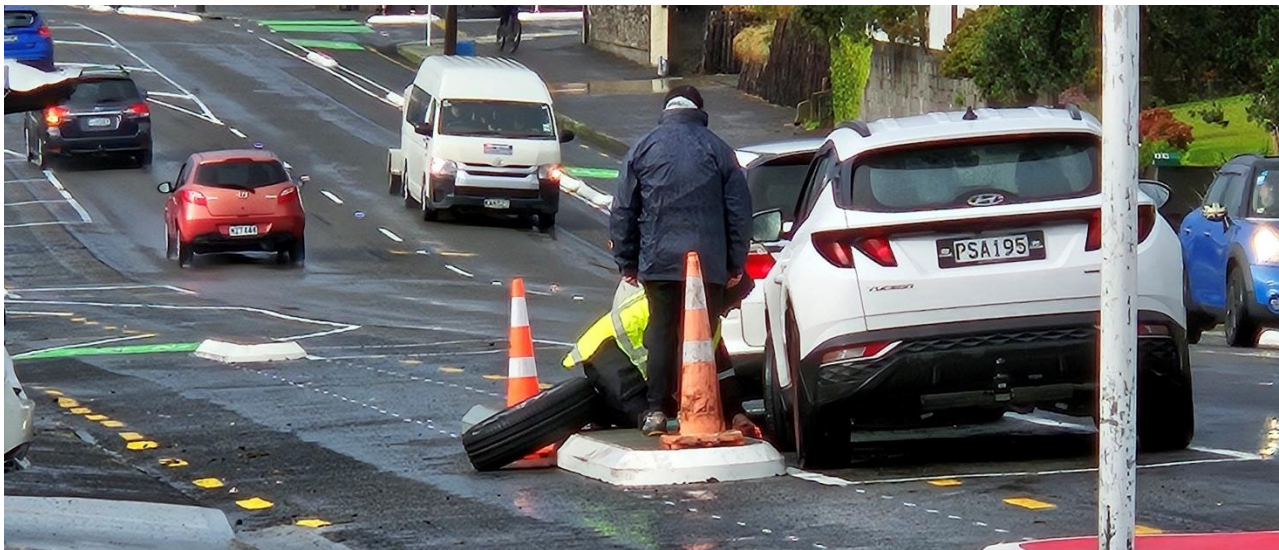
This design has caused considerable concern and discussion by road users and local stakeholders. A particular concern raised involves motorists unable to pull over to let emergency vehicles through in an emergency. The steep sides of the concrete cycleway separators discourage vehicles from pulling into this space as the separators appear to be unmountable and higher than they actually are. Whilst the non-mountable profile helps to discourage encroachment into the cycleways, it is resulting in damage to both vehicles and the separators where there is a collision. It is evident that there have been many collisions with the separators to date, noting the tyre marks and damage caused to the separators along the corridor. A collision resulting in a tyre blowout during our site visit is shown below in **Figure 4-6**.

Figure 4-6: Damage vehicle due to collision with the concrete cycleway separator on SH45 / Devon Street West

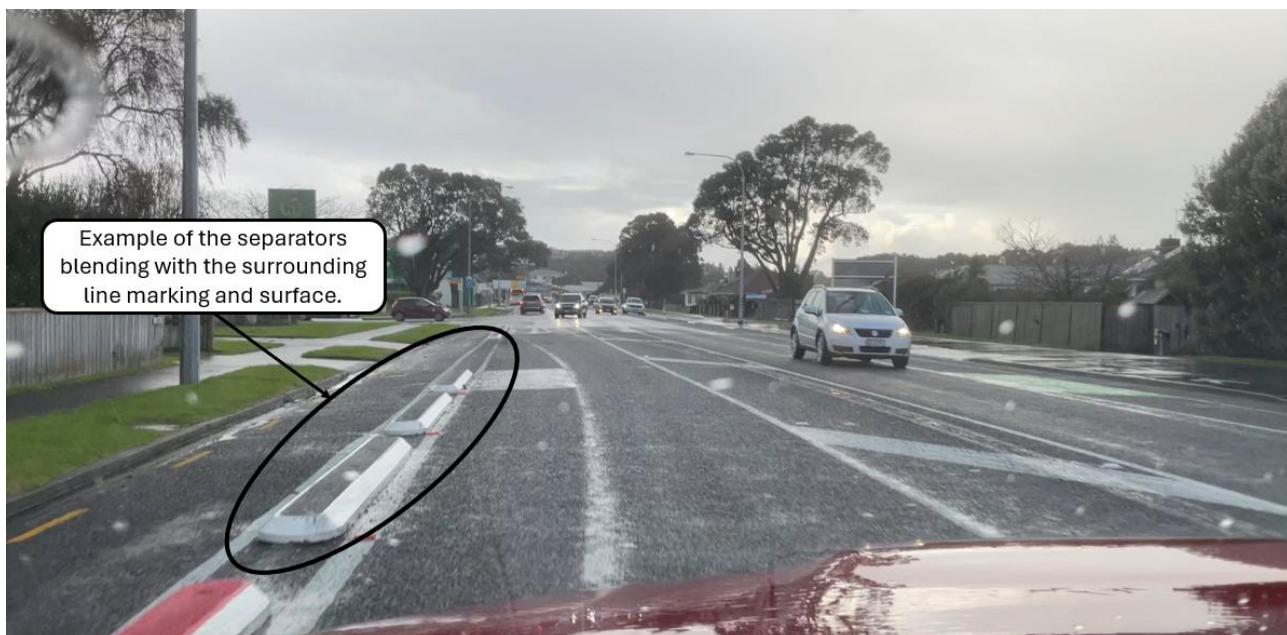
In addition to this, most of the cycleway separators currently have only their edges painted white, while the tops remain unpainted. The dull grey exposed aggregate tops of the separators make the kerbs relatively unobtrusive and appear similar to the adjacent road surface in low light conditions. In some instances, the first and occasionally the last separator is painted red on top, but this is not consistent throughout the corridor. See **Figure 4-7** below.

Figure 4-7: Cycleway separators composition matching the surroundings

The absence of red paint on top of the separators makes them harder to spot as the white sides can resemble standard line markings, rather than a raised separator. Additionally, the edge line of the traffic lane is hard up against the base of the separator which somewhat blurs the distinction between the concrete separator and traversable line marking.

- The SAT recommend that all separators are painted red on top to increase their visibility during all hours of the day, and differentiating them from the typical edge line marking.
- If space allows, offset the edge line into the lane to provide a small buffer zone between the concrete separator and the traffic lane.
- Investigate the use of alternative, more forgiving separator designs. These could be trialled in targeted areas and when replacing damaged concrete separators
- The operation of the cycleway and the crash statistics should be reviewed again within the next six months once drivers have had a chance to adjust to the new road formation.

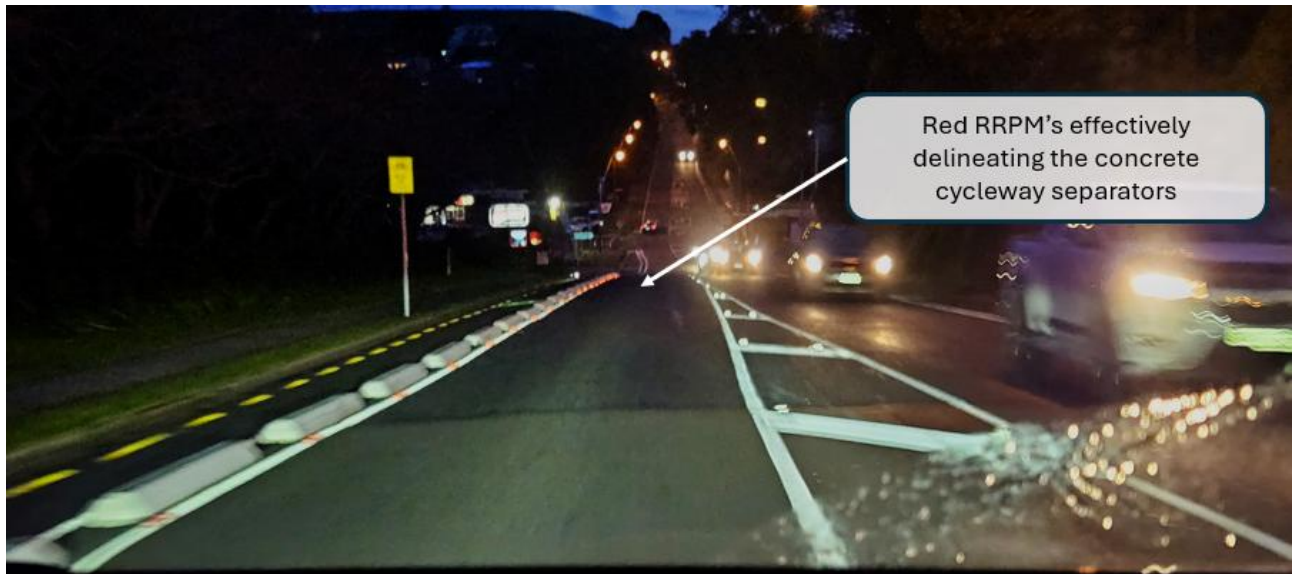
It is noted by the SAT that the visibility of the separators is increased during dark hours due to the red raised reflective pavement markers (RRPM's) that has been installed on the traffic lane side of the separator. These provide clear delineation between the separators and the edge of the traffic lane. This is shown below in **Figure 4-8**.

Figure 4-8: Red RRPM's effectively delineating the concrete cycleway separators on SH45 / Devon Street West

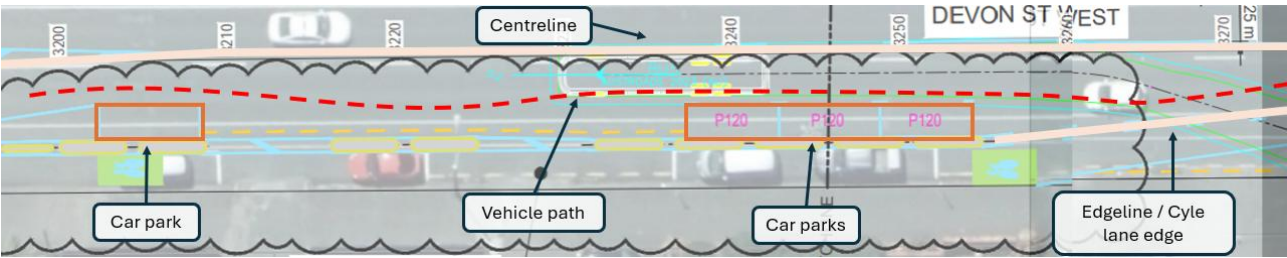
Four new car parks on SH45 / Devon Street West, located outside the 299 Motel in the mid-block section between Morley Street and Cutfield Road, extend quite abruptly toward the live traffic lane. This means that drivers need to ‘weave’ around the parked vehicles as opposed to driving in a straight line. This is exacerbated by inadequate delineation of the travel lane between the car parks and the travel lane meaning drivers are not guided to safely shift towards the centreline and away from these parking spaces. This increases the likelihood of rear end and side swipe type crashes as vehicles may swerve to avoid an unexpected, parked vehicle in their perceived travel lane. The weaving movement is shown below in **Figure 4-9**.

Figure 4-9: Weaving vehicle movement (red dotted line)

- Install an appropriate form of marking or guidance, such as a continuity line and/or edge definition to better position the through traffic to their lane. This will encourage better lane discipline, move the passing traffic away from the parked vehicles and offer an increased margin for door opening. This would also offer a greater margin of safety for pedestrians walking out mid-block between parked vehicles to cross the road.
- Replace the car park line marking with high performance line marking to increase their visibility, particularly in low light conditions.
- The lone parking bay near Cutfield Road intersection could be removed or joined with a continuity line with the three to the east.

**Client Decision:** Agree with Designer and Safety Engineer recommendations. A continuity line with long-life markings to be installed.

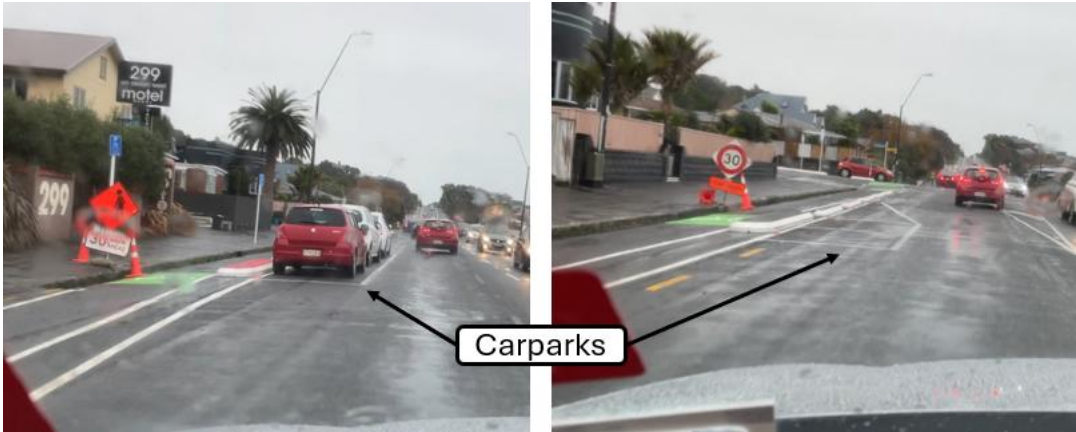
An instance where this is particularly apparent is a lone parking space to the west of the first group of three (outside 305 Devon Street West). This space also sits next to a right turn median taper which directs drivers away from the centreline and closer to the parking space. A pinch point or bottleneck is effectively created, further exacerbating the feeling of parking spaces protruding into the live traffic lane.

Figure 4-10: Ineffective car park line marking and carparks appearing to protrude into the live traffic lane

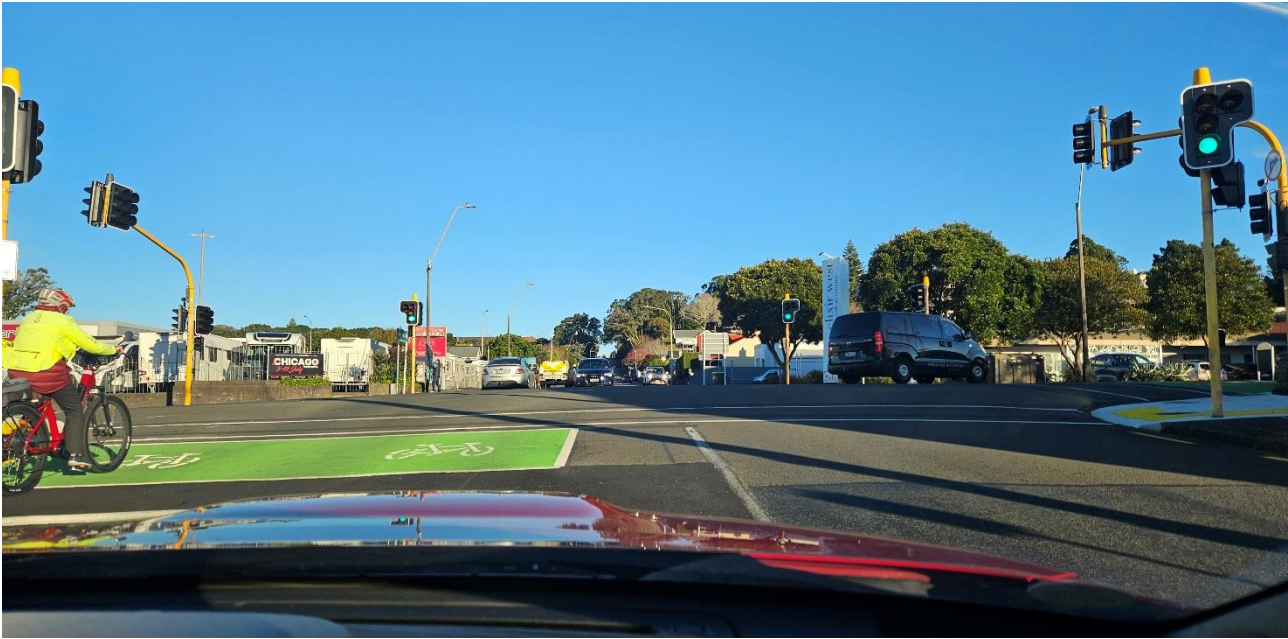
At the SH45 / Devon Street West / Morley Street intersection, the right hand turn movements from Morley Street onto SH45 / Devon Street West are now controlled by filter turn signals. With the gradient of Morley Street on the northern approach and the further set back hold line, there are visibility constraints for vehicles turning right. Additionally, these vehicles start on an incline, which takes additional time to accelerate and make the turn. This makes it difficult for these drivers to gauge an appropriate gap to make the right turn in between the priority straight through movements. This increases the likelihood of intersection type crashes for right turning vehicles. See the available sight distance in **Figure 4-11** below.

Figure 4-11: Sight distance when waiting to turn right from Morley Street onto SH45 / Devon Street West

**Client Decision:**      Agree with Designer and Safety Engineer recommendations. Right turn pocket markings to be installed, without right turn green signal arrows.

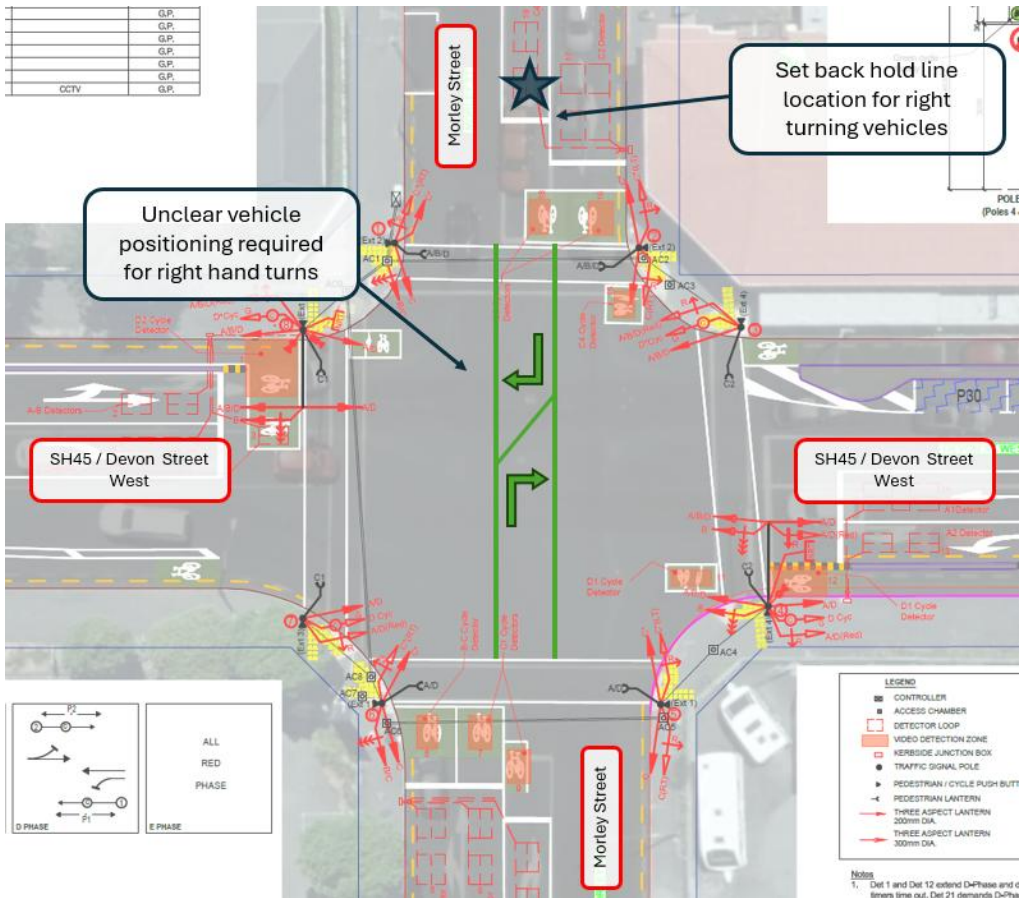
The vehicle positioning required for these right hand turns is also unclear. Drivers turning right may not be guided properly at the intersection and encroach into the opposing vehicle lane when making these right turn movements. The lack of position guidance within the intersection before turning further increases the likelihood of intersection type crashes for right turning vehicles. This is shown in **Figure 4-12** below.

Figure 4-12: Unclear vehicle positioning and lane delineation for right turning vehicles at the SH45 Devon Street West / Morley Street intersection

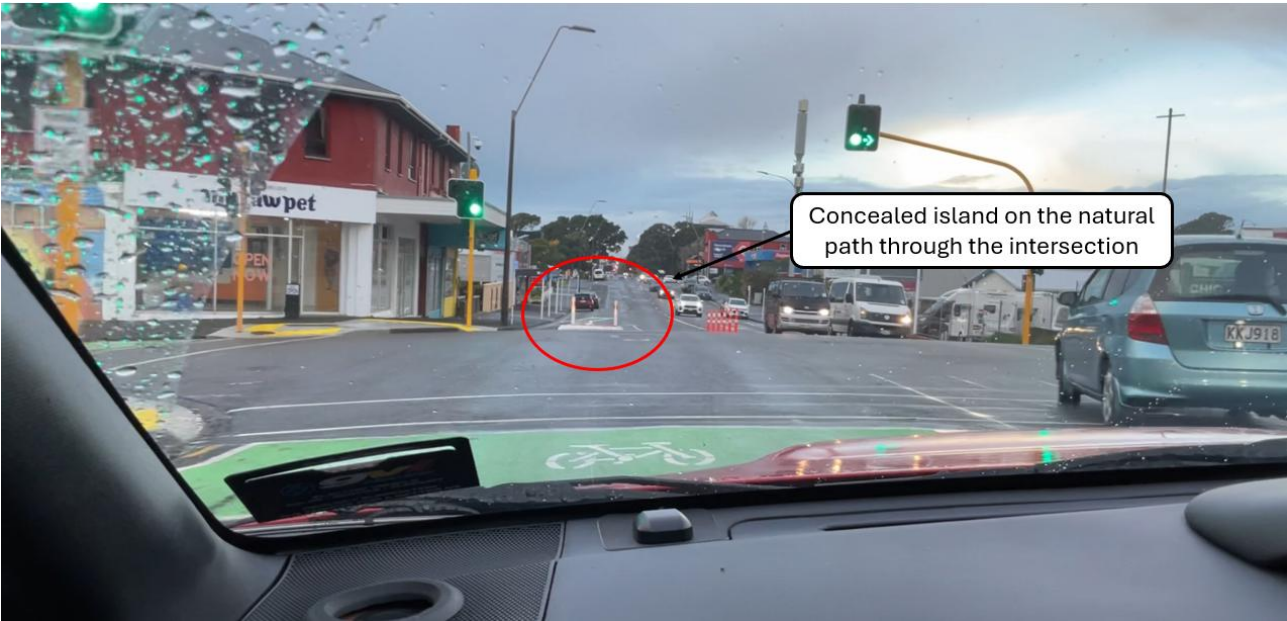
Eastbound traffic passing through the Morley Street and SH45 / Devon Street West intersection now encounters a kerb build-out on the eastern side of the intersection. This requires vehicles to deviate from their usual path when travelling towards New Plymouth’s CBD. The build-out is partially concealed by the high point at the centre of the intersection, making it difficult for drivers to spot until they are already well into the intersection. This increases the likelihood that motor vehicles will mount the kerb or have to swerve suddenly to avoid the island. The island is marked with two slim-profile edge marker posts, which somewhat enhance its visibility. However, these posts tend to blend into the background created by the cycle lane separators positioned behind the island, reducing their overall effectiveness.

Drivers face the risk of colliding with or driving over the island, which could lead to a run-off-road crash. However, the likelihood of severe crashes at this location is relatively low, as it is expected that vehicles are typically travelling at lower speeds through intersection. The islands concealment is shown below in **Figure 4-13**.

Figure 4-13: Concealed island in the natural path of vehicles heading eastbound through the intersection.

- The SAT recommend that a reflective directional sign is installed on top to help better guide eastbound drivers to deviate slightly to the right when travelling through the intersection such as ‘keep right arrow’.

**Client Decision:**      Agree with recommendations. RD6R Keep Right Arrow, white delineator post, and priority lane line to be installed.

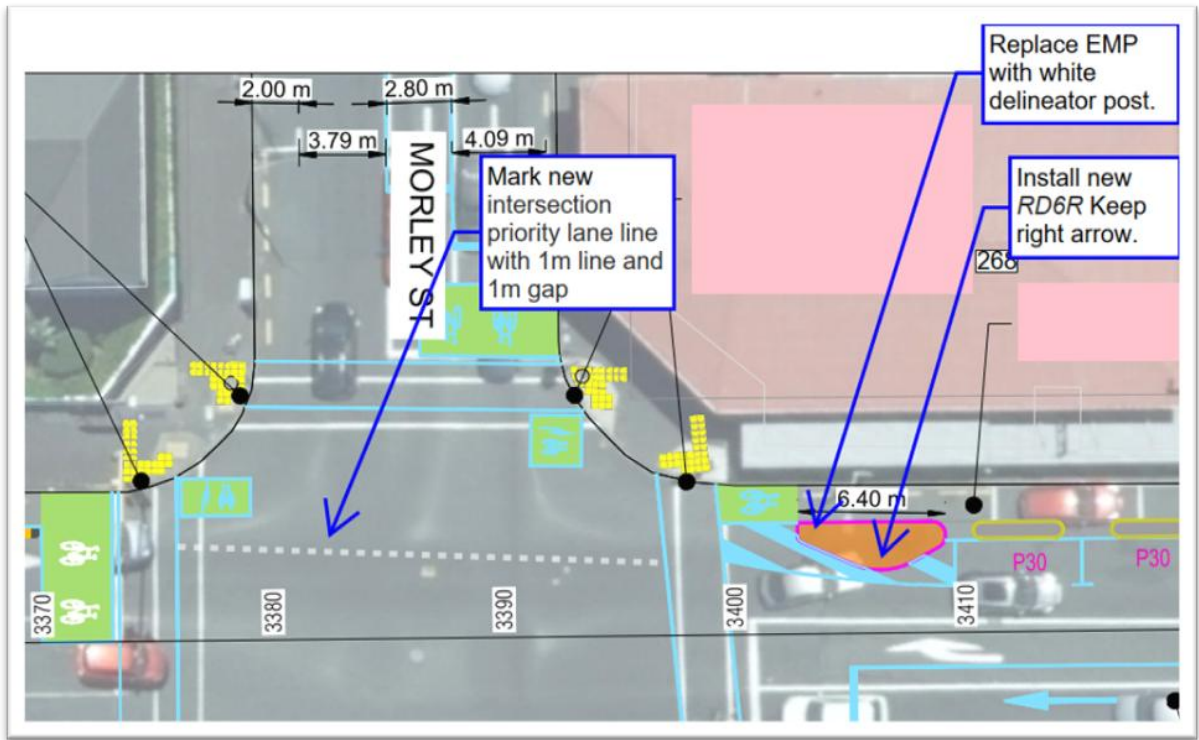
White edge marker posts (EMPs) are not an appropriate form of delineation in the urban area or for this type of application. We agree that an RD6R Keep Right Arrow sign should be used to replace the EMP in the right of the photo. We also recommend that the edge marker post on the left of the photo is replaced with a white delineator post. An intersection priority lane line could also be marked to delineate the edge of the traffic lane through the intersection as shown in the image below.

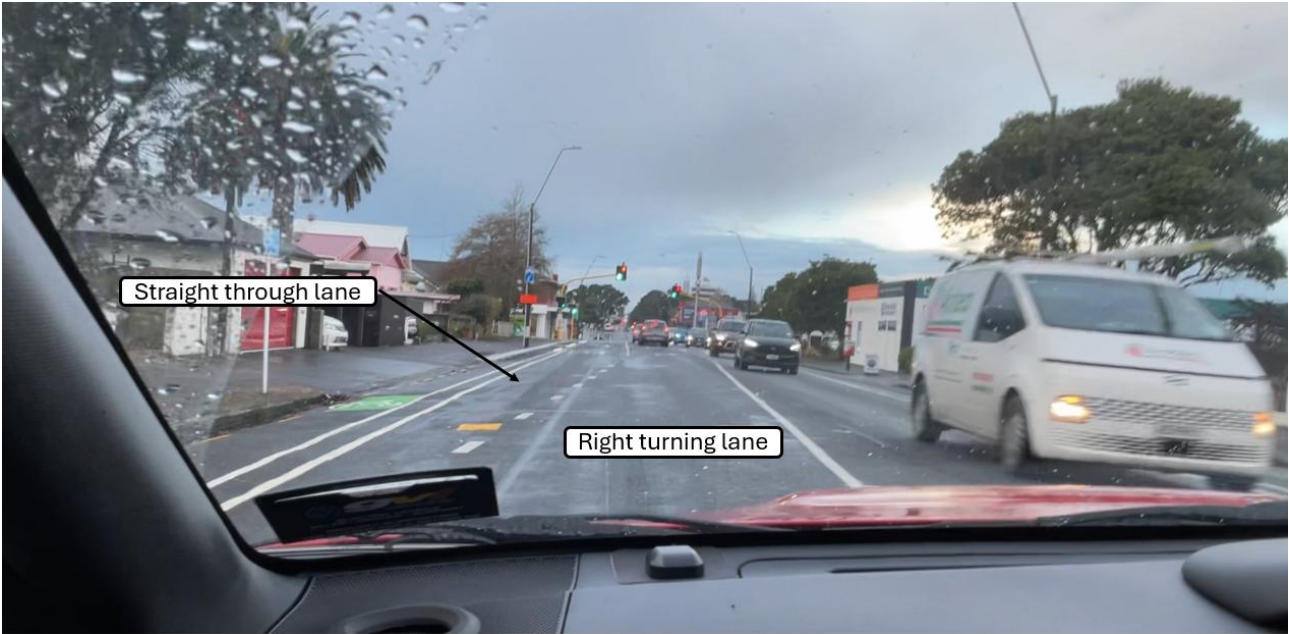
The eastbound traffic lane approaching the Morley Street intersection is configured as a trap lane. This design directs the travel lane into an exclusive right-turn onto Morley Street. While this is the most common eastbound movement at the intersection, the trap lane increases the risk of side-swipe and rear-end crashes. This occurs when drivers or riders attempt to switch lanes late to continue traveling straight through the intersection.

Figure 4-14: Traffic lane turning into a right turning lane

- The SAT recommends replacing the trap lane with a channelised turn lane where feasible. If this isn't possible the addition of an advance lane arrow on the intersection approach should be implemented.

**Client Decision:** Agree with Designer and Safety Engineer. No changes from the design required, however the missing marking from the design to be installed.

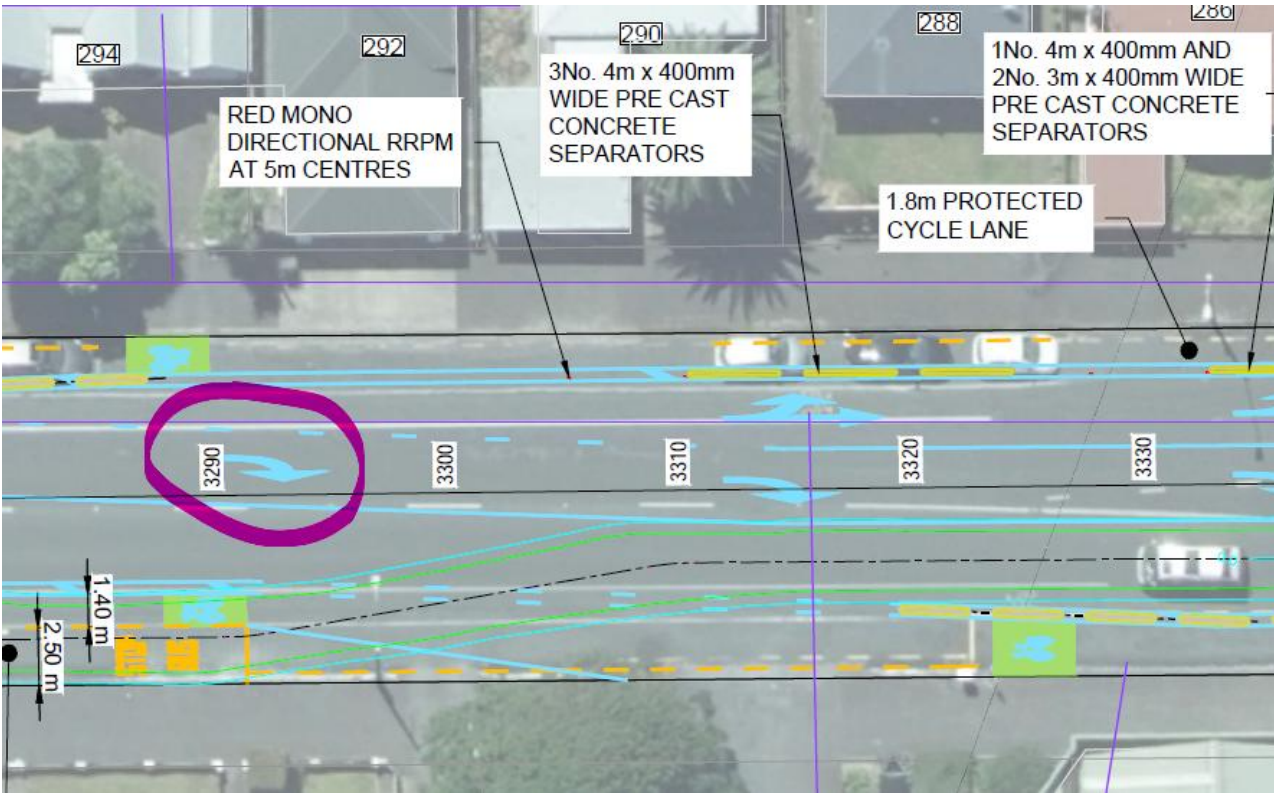
**Design Team Response:** The design of a captured lane was deliberate and guided by the wishes of the two road controlling authorities involved. The intention was that by default, drivers would follow the alignment of the state highway, rather than being channelled into the central city. That said, it has been noticed that the design has not been fully implemented, as the first right turn arrow that approaching drivers would face is missing. This should be retrofitted, as it avoids trapping drivers inadvertently in the exclusive right turn lane. The missing lane arrow is highlighted on the figure below.

**Action Taken:** Missing marking has been installed.

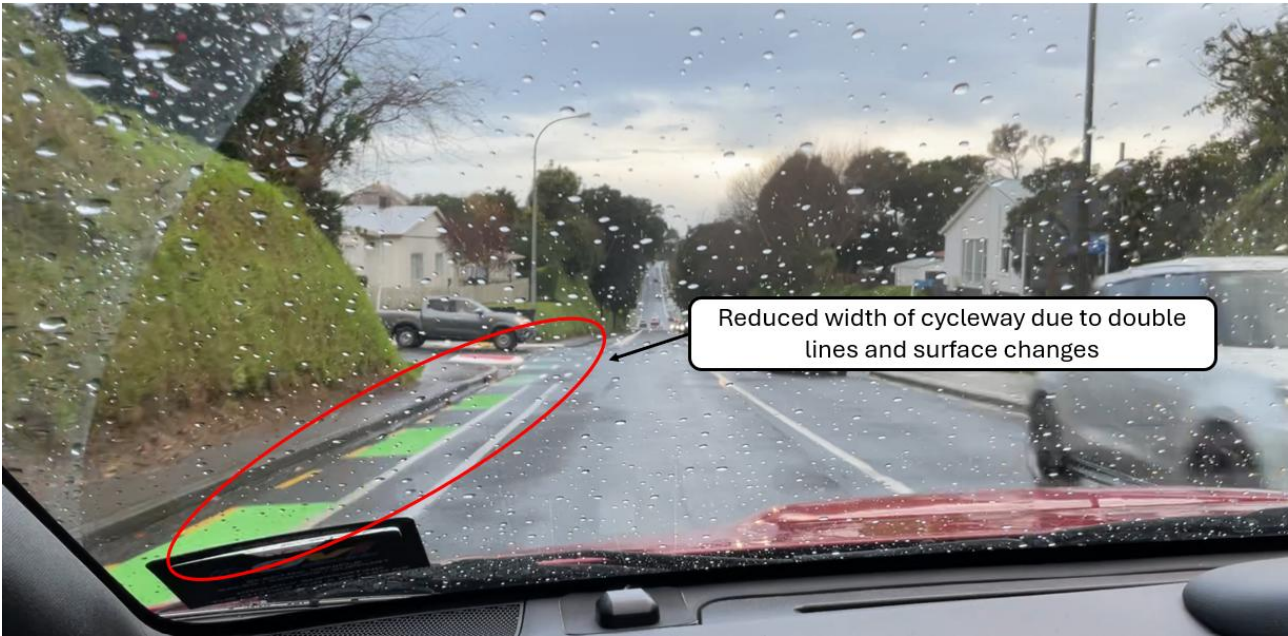
Throughout the SH45 / Devon Street West and South Road corridor, the width of available cycle lane differs significantly, with some sections being extremely narrow. The sections of narrow available widths are limited further by uneven surfaces and seal joins, deep stormwater drainage channels, and double line markings. In some sections, such as the section shown below in **Figure 4-15** this narrow width is compounded by the existing steep gradient and drop into the adjacent drainage channel.

Figure 4-15: Narrow cycleway width caused by line marking, surface changes, and drainage channels

These constraints confine cyclists to a reduced portion of the lane, offering them less room to manoeuvre and increasing the risk of cycling into the adjacent live traffic lane. The exposure and likelihood risk for this crash type is increased due to the number of schools along the corridor, which increases the probability of younger and inexperienced cyclists utilising this route.

- The SAT understand that some of the uneven surfaces are due to various reseals joining and creating a lip. When the road is programmed for its next reseal, these areas with a lip greater than 5mm and uneven seal join, should be repaired to create a smooth and even finished surface.

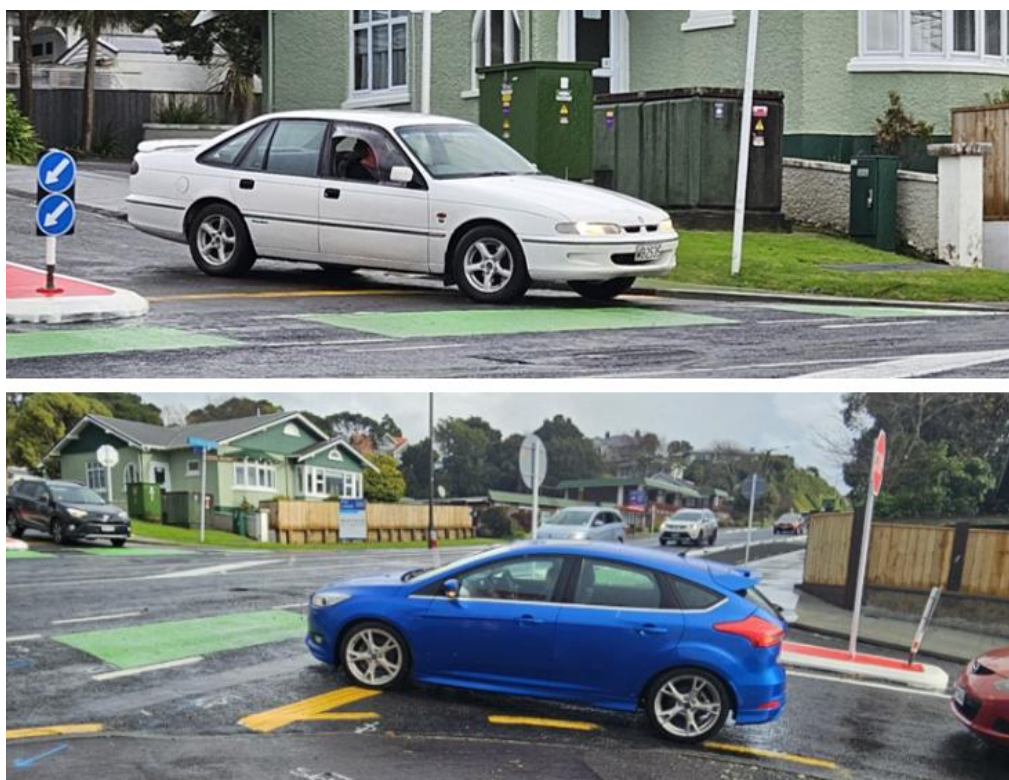
It was observed on site that vehicles waiting at the side road intersections were stopping over the new hold line and encroaching onto the cycle way. Notably, these hold lines are set back further than the previous hold lines at these locations, which may lead to restricted or the perception of restricted available sight distance. Drivers stopping over the limit line and encroaching onto the cycle lane may result in cyclists riding into the side of the car or manoeuvring type crashes when cyclists deviate out of the cycle lane into the traffic lane. These vehicle behaviours are shown below in **Figure 5-1**.

Figure 5-1: Some examples of vehicles stopping over the holding line and encroaching into the cycle lane

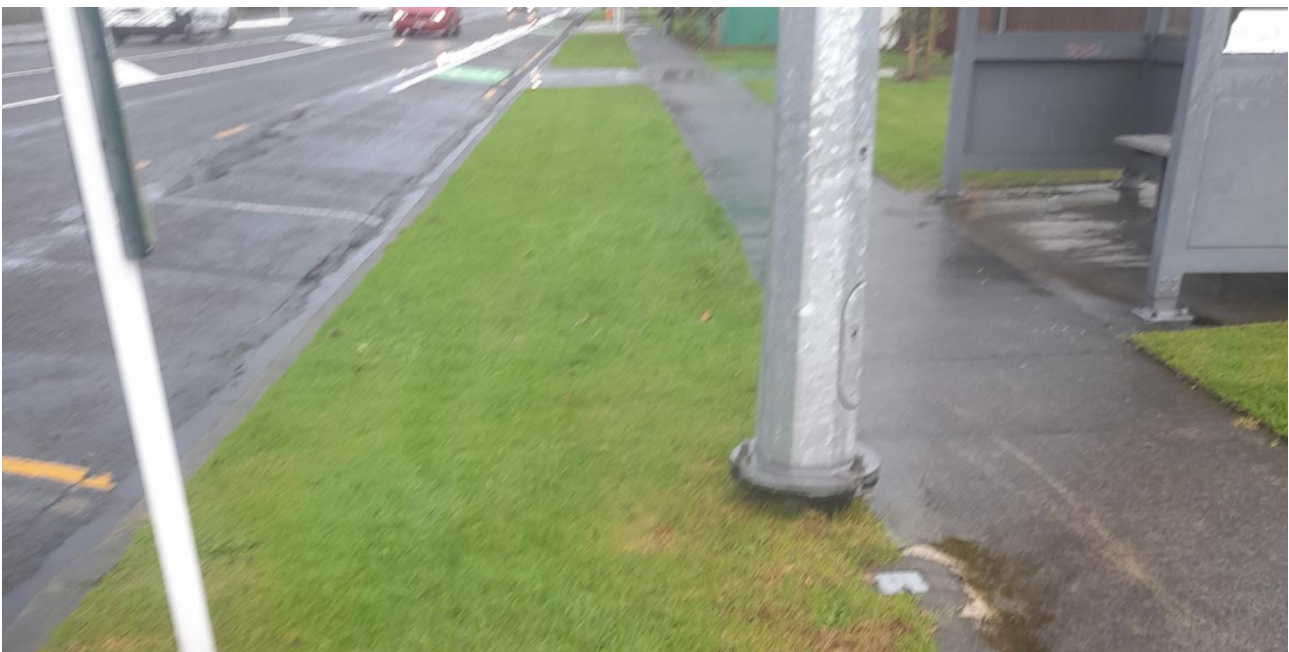
At the western end of the SH45 / South Road corridor, a newly constructed bus stop is located on the western side of the road. Adjacent to the bus stop, there is a wide berm between the kerb and footpath; however, no direct connection currently exists between the footpath or bus shelter and the bus stopping location. This presents challenges for users accessing the bus, particularly those mobility-impaired and visually impaired. Such limitations represent a reduced level of service and may hinder these individuals from utilising the bus service effectively.

The issued for construction (IFC) drawings show a connective platform was proposed for this location but that has not been installed as per the site visit on the 15<sup>th</sup> July 2025. The berm is shown below in **Figure 5-2**.

Figure 5-2: Bus stop with no footpath to bus connection.
