2 Johnston St, Waitara

Preliminary Site Investigation

For Hareb Investments Ltd

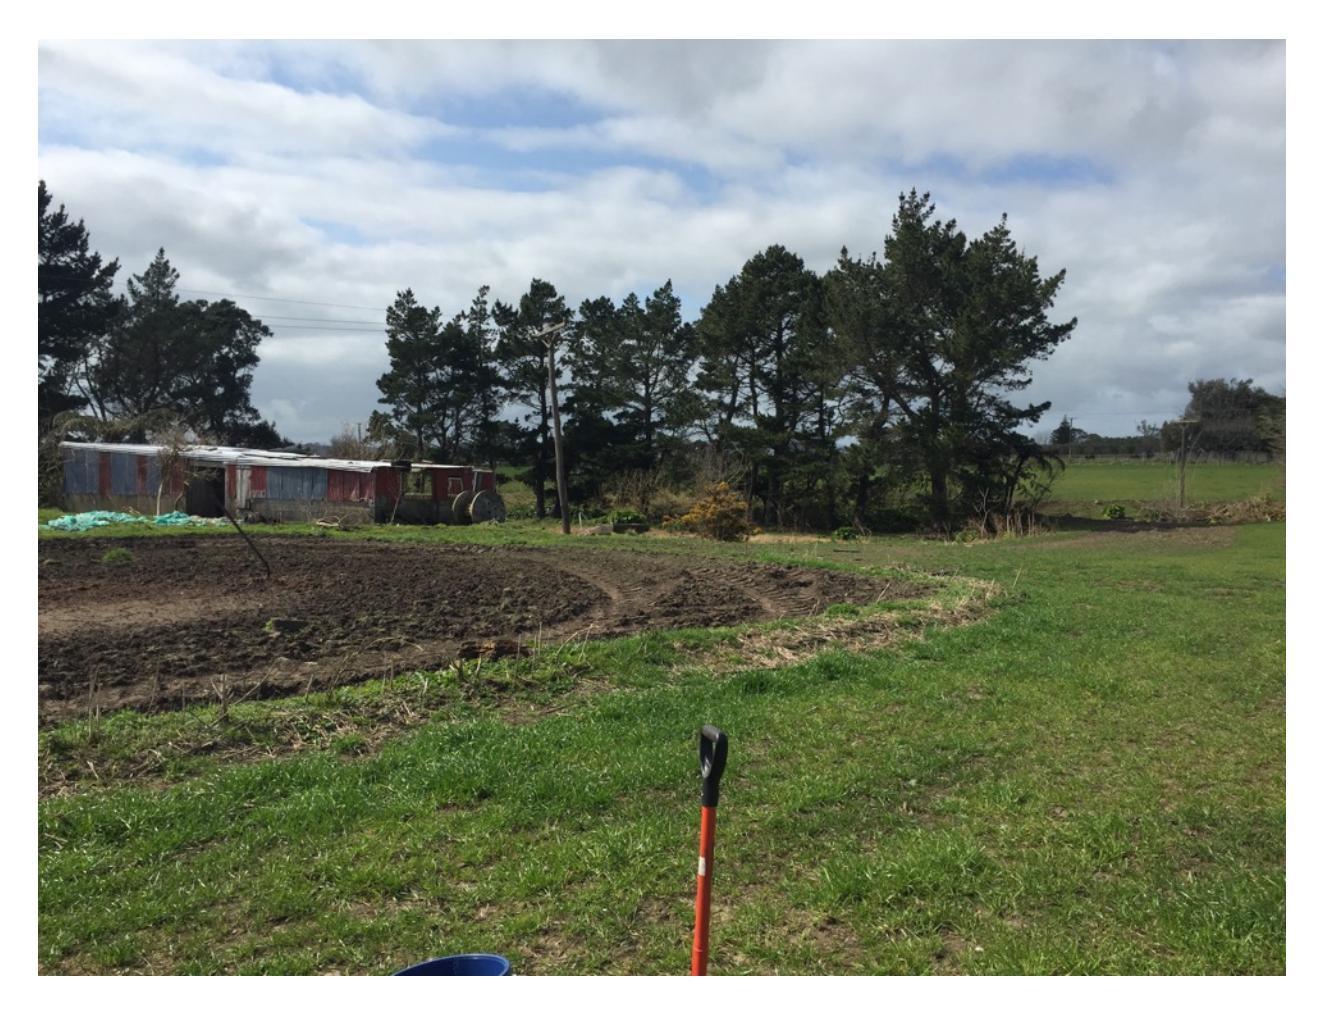
Figure 3 – A typical view of the site, looking north from the location of sample S7 (see Figure 12 for sample locations)

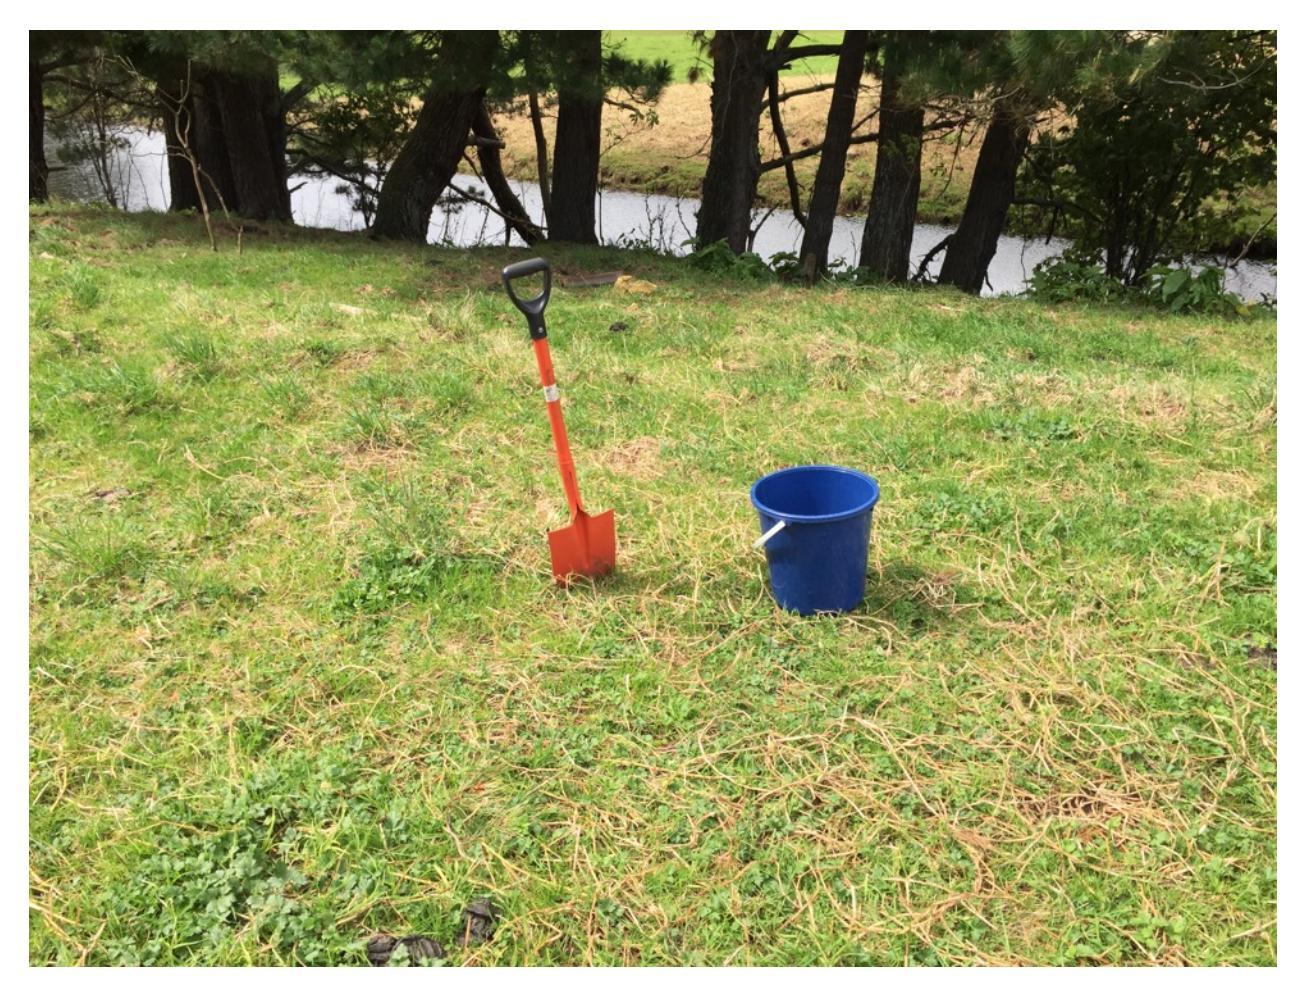
Figure 4 – Sample location S5, showing stream in background.

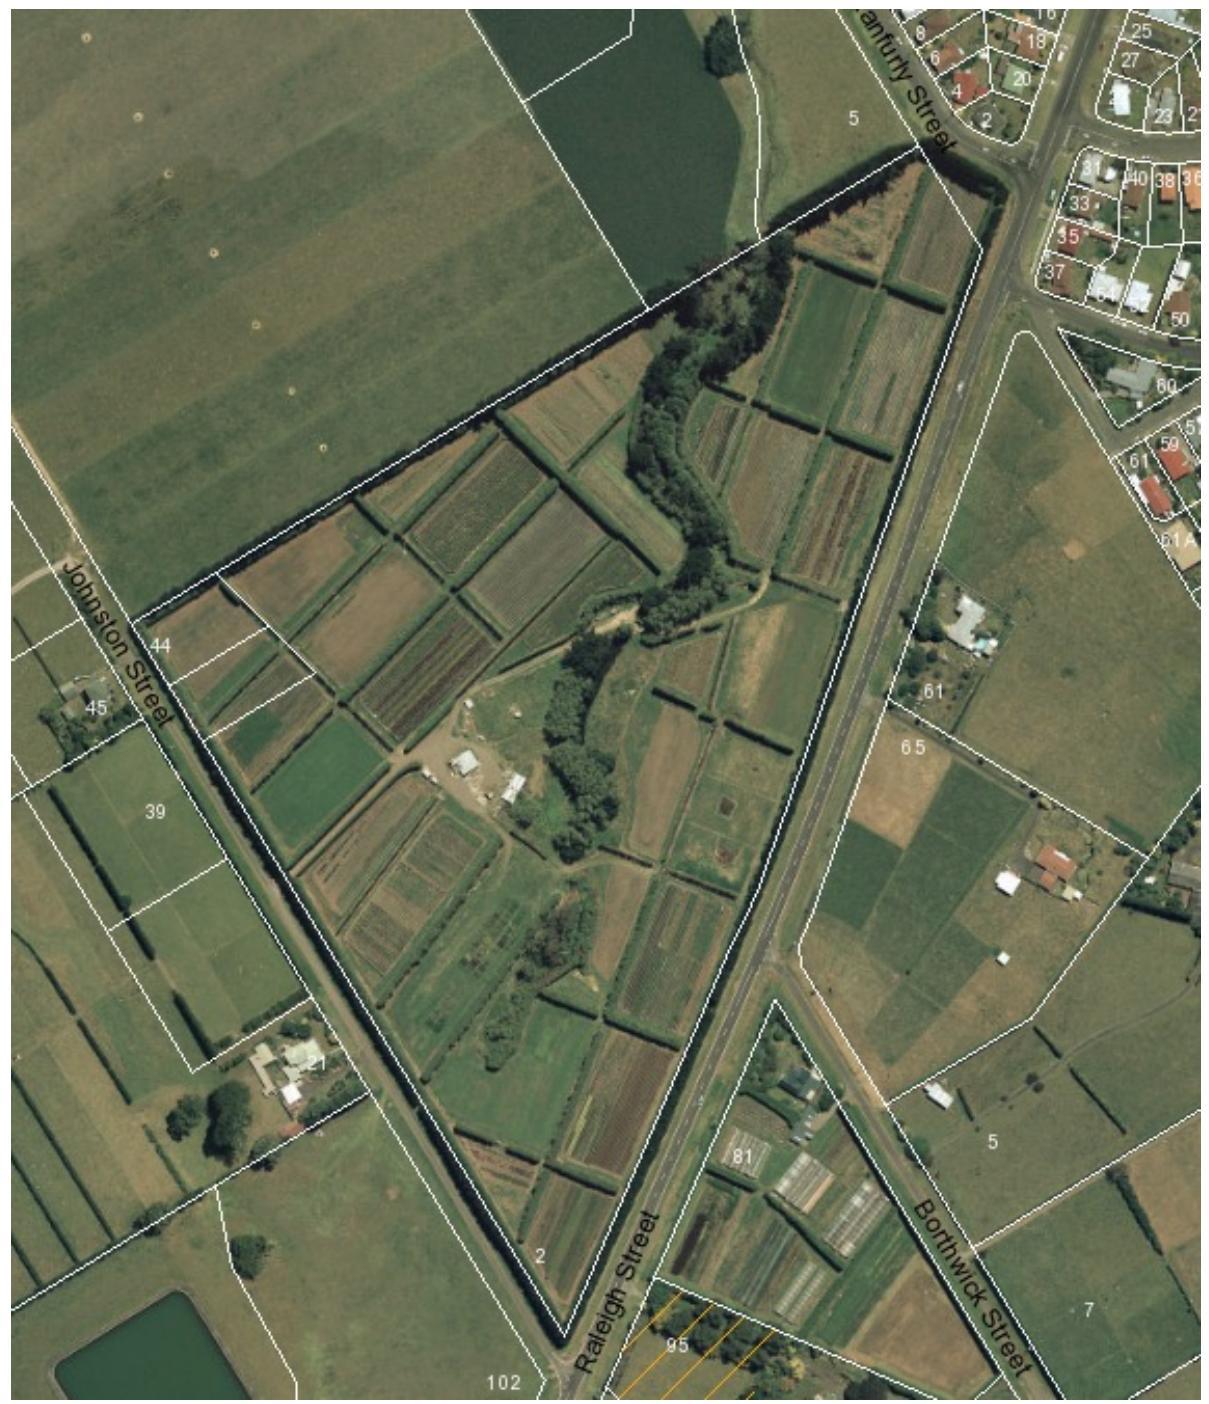
Figure 8 – 2001 aerial photograph, showing present property boundaries (source: NPDC GIS viewer)

By 2001, the site had been redeveloped for market gardening or a similar horticultural activity. At least 7 sheds or other small buildings were present in a yard area near the centre of the site. Some materials (probably pellets and timber beams) were being stored outside in the same area.

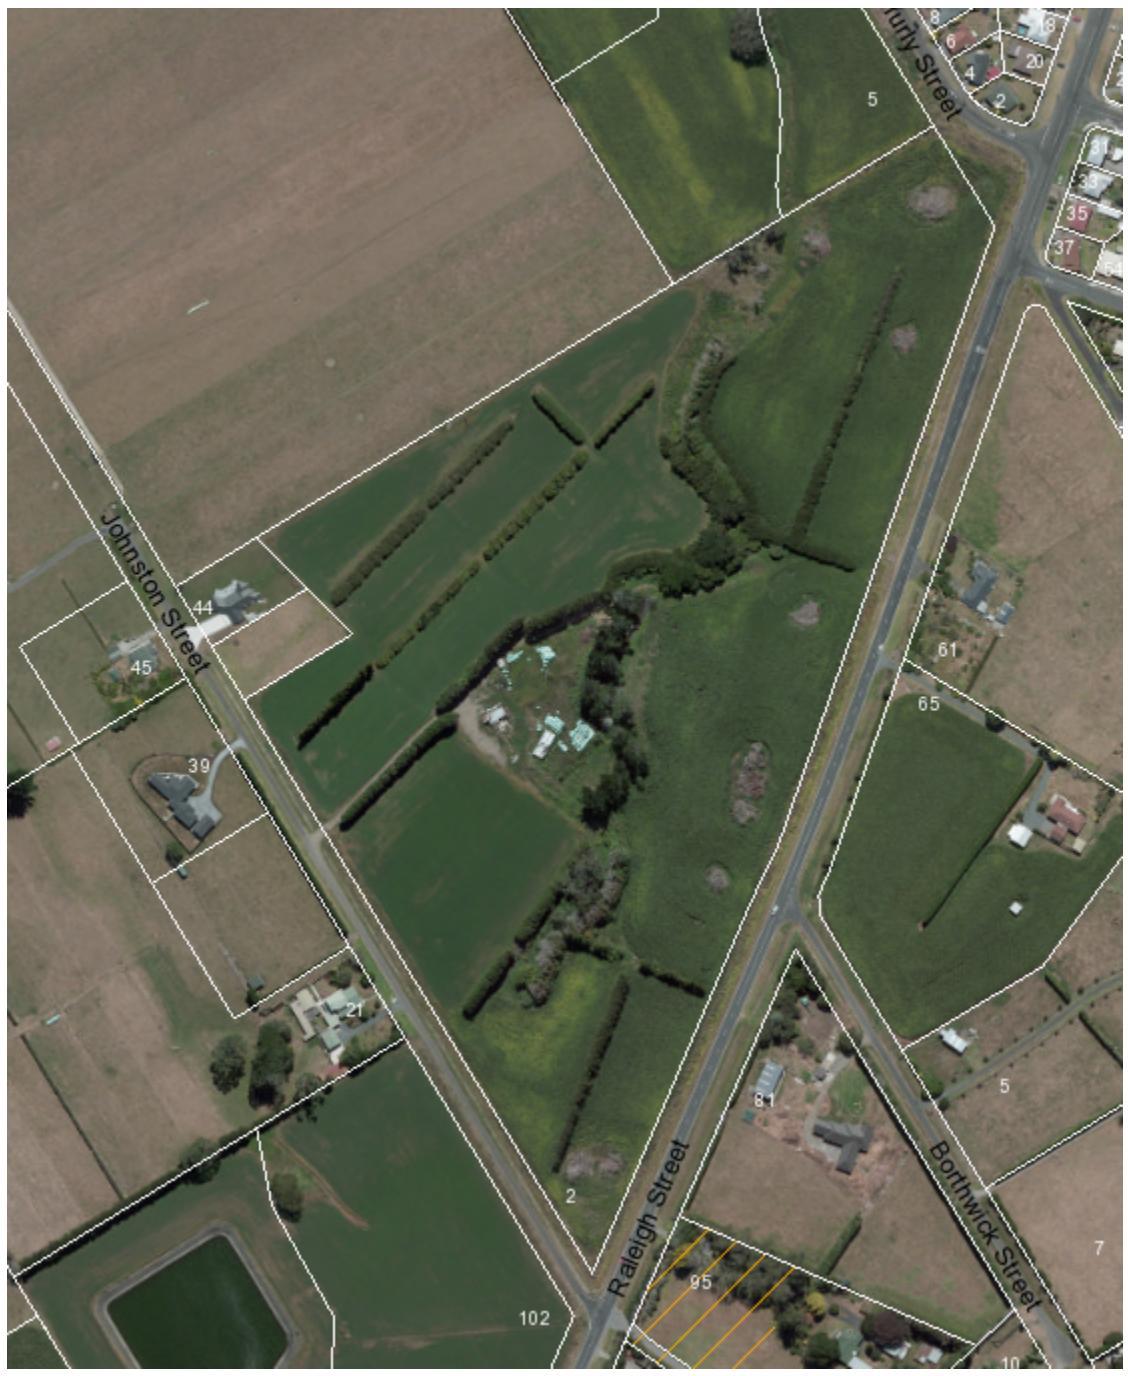
Figure 11 - 2013 aerial photograph (NPDC GIS viewer)

The 2013 photograph shows that horticultural activity at the site had finished by that time. Many of the shelterbelt trees had been removed. Approx. 10 piles (presumably of tree stumps) had been formed in the eastern and northern parts of the site. Most of the smaller sheds had been removed, and the remaining buildings were falling into disrepair. Large areas of the yard were being used to store wrapped hay bales.

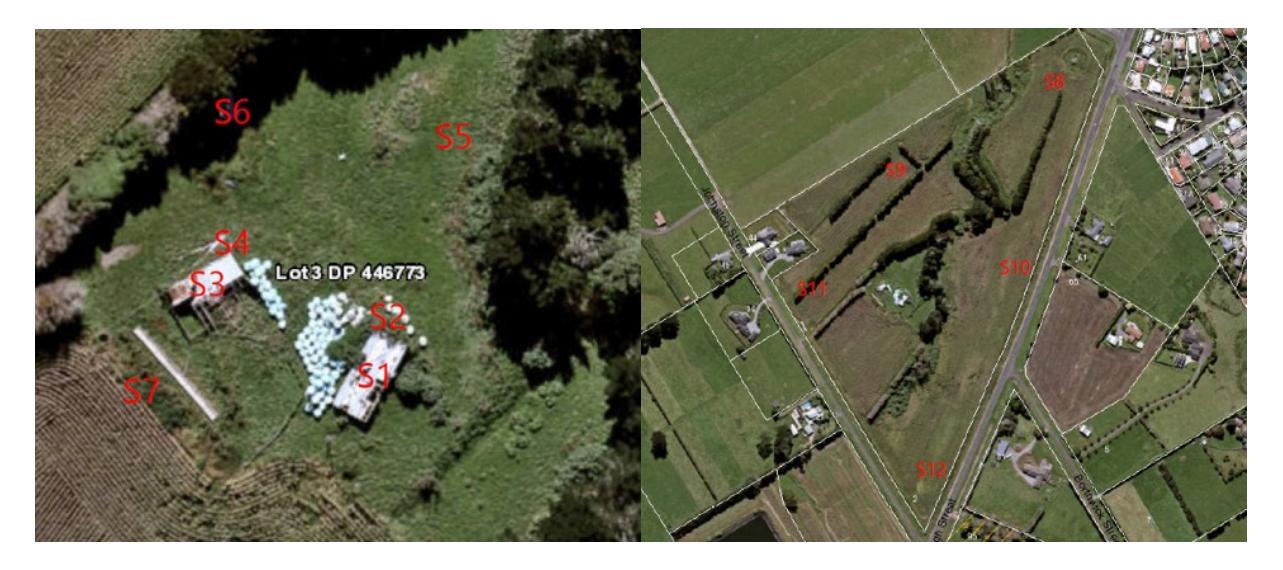
To provide initial evidence to test the CSM, 12 soil samples were collected at the site. Samples S1-S7 were collected in the yard area near the current and former buildings on the site, while samples S8-S12 were collected in the paddocks around the remainder of the site.

Figure 12 - Approximate sample locations over 2016 aerial photo from NPDC GIS viewer. Left: samples in yard area; right: samples in rest of site.
