Oakura Beach Walk - 16 February 2018

KEY COASTAL FACTS

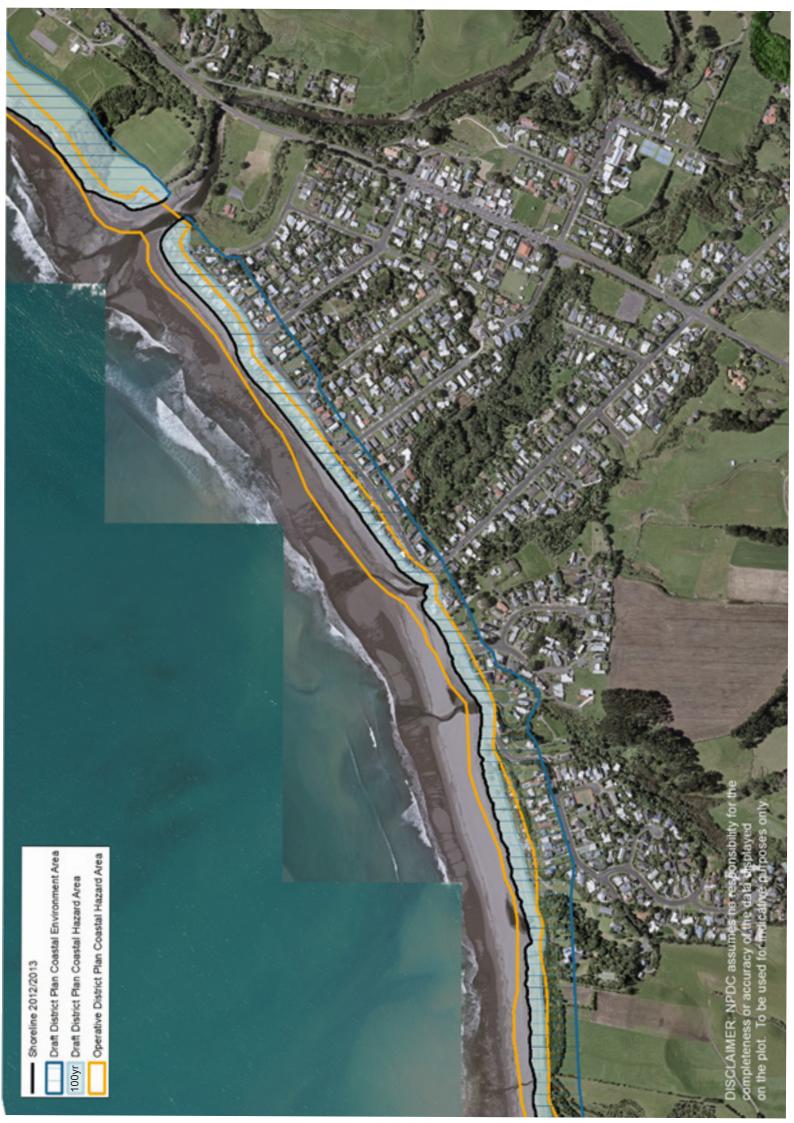
The yellow lines show the coastal hazard area, which was calculated in 1988 and is currently in the Operative District Plan. The seaward extent of the yellow lines shows the distance the coast has eroded since this time.

The blue-shaded zone shows the area that may be affected by erosion and land instability in 100 years if erosion continues at current rates. This zone ignores coastal protection works as they may not be effective over 100 years.

Erosion rates may increase with future climate change and sea level rise. This has not been incorporated into the blue-shaded coastal hazard area but is being investigated.

The coastal erosion hazard area includes future erosion of the beach and dunes by storms and changes in sediment supply, and erosion of the cliff toe and land areas above (which may become unstable).
