# Assessment of the Te Oropuriri Road Alignments

30<sup>th</sup> September 2014

New Plymouth District Council  
Private Bag 2025  
New Plymouth  
New Zealand 4342

Geometria Limited  
3/3 Margaret Street  
Freemans Bay  
P.O. Box 68-653  
Newton 1045  
Auckland

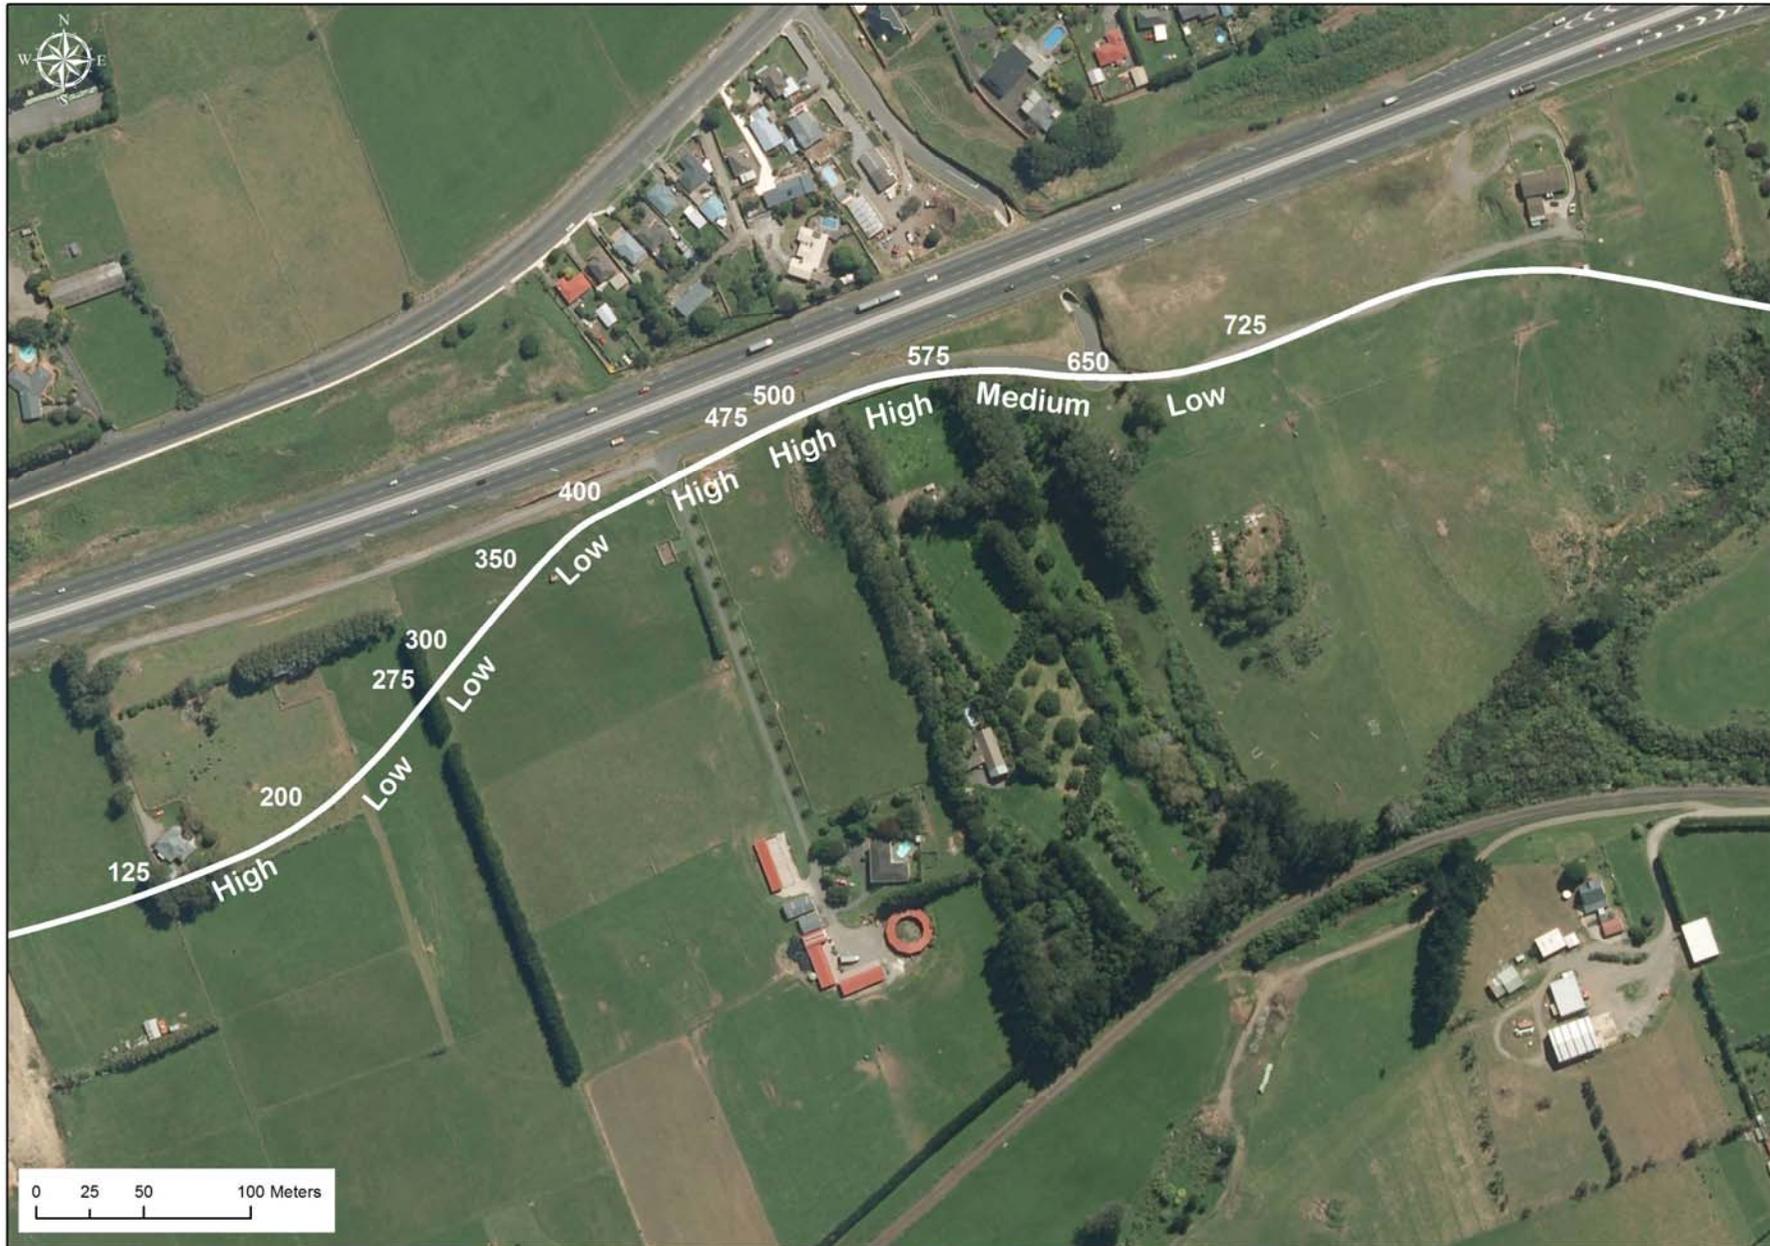
Figure 2: Distance in metres along the Northern Alignment showing level of risk. Refer Table 1 for estimated archaeological cost per section.

For a large section of the route adjacent to Te Oropuriri the archaeological risk is clearly defined as high due to previous excavation results and the presence of known archaeological features (Figure 2). These include a continuation of the defensive trench, whares and pit features, and features associated with the later Broughton occupation. As the Northern Alignment corridor is contiguous with the previous Te Oropuriri excavations as it passes the pa, it has the advantage, from an archaeological perspective, of providing a continuum of knowledge extending the archaeological understanding of Te Oropuriri. Further archaeological discovery is guaranteed and the type and density of features is expected to be similar to previous excavated features immediately to the north.

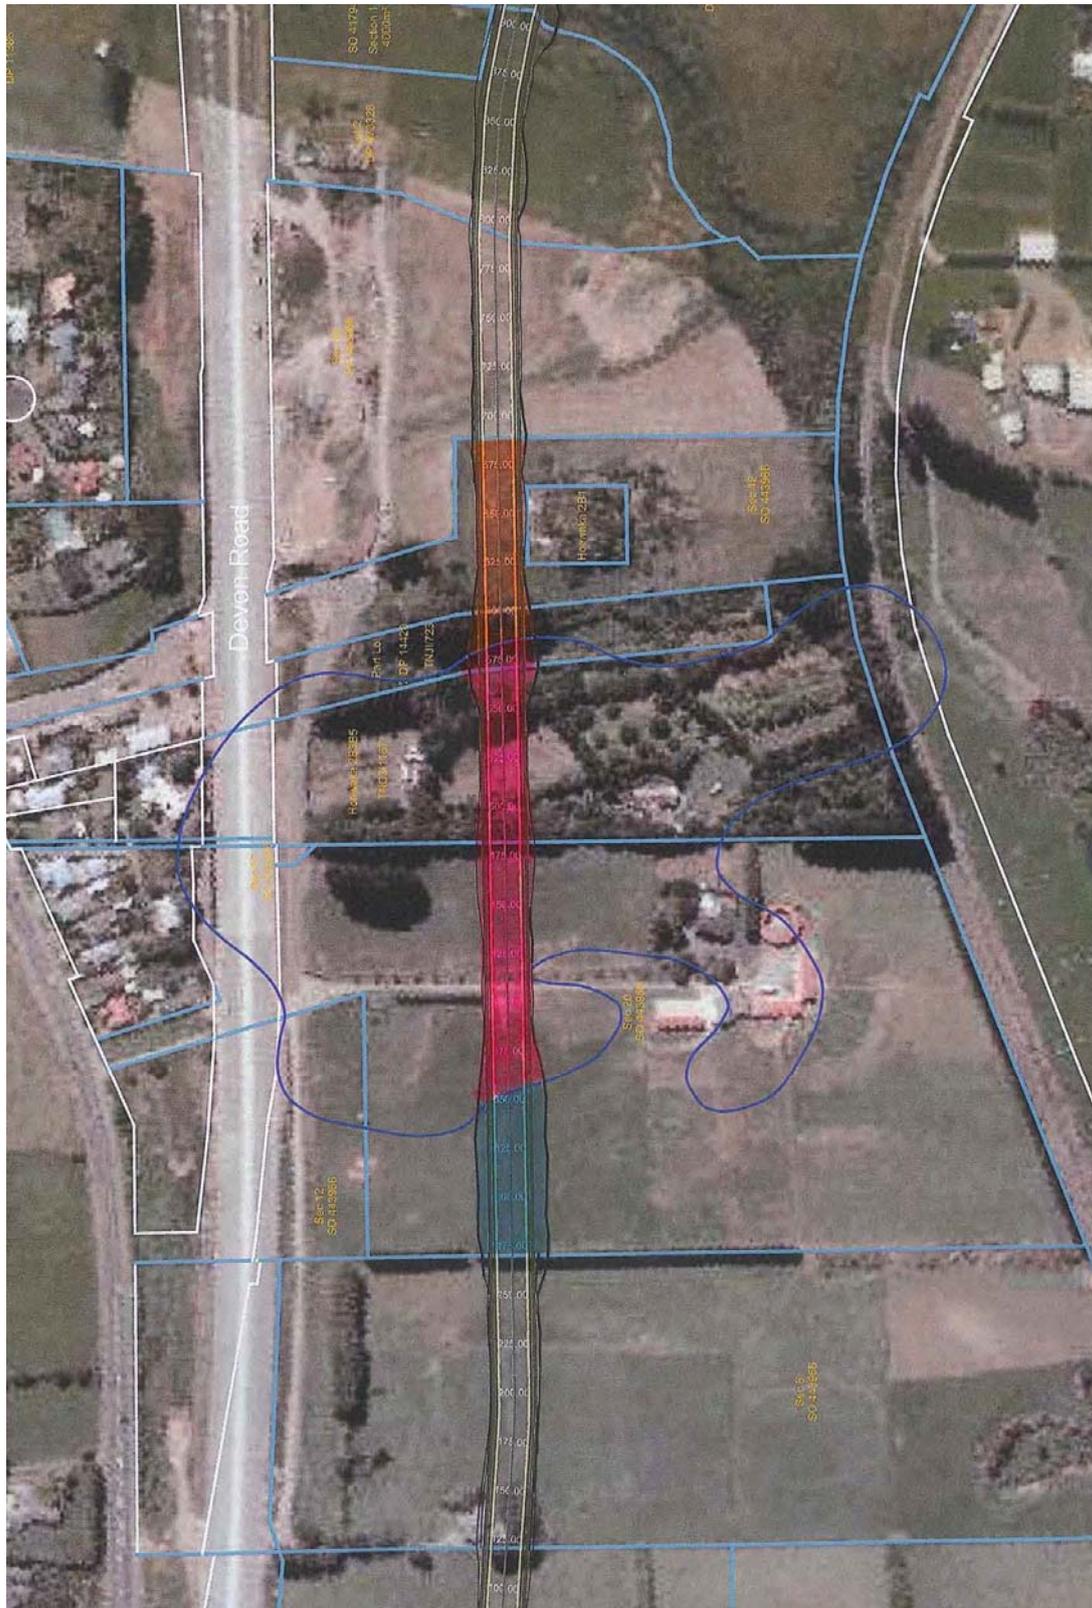
Figure 3: The Central Alignment route.

The more direct route of the Central Alignment (Figure 3) will pass through what is interpreted, in general, as probable lower density archaeological areas than the Northern Alignment, being further south of the known concentration of features associated with Te Oropuriri. However, this alignment crosses over areas of varying archaeological potential with some known archaeological deposits and carries a high degree of archaeological risk through the Te Oropuriri/Caskey ridgeline and Rowe property (Figure 4). The sloping gradient of the open orchard ground on the east of Te Oropuriri ridgeline may reduce the archaeological potential of this area due to this not being entirely suitable for occupation features such as whares.

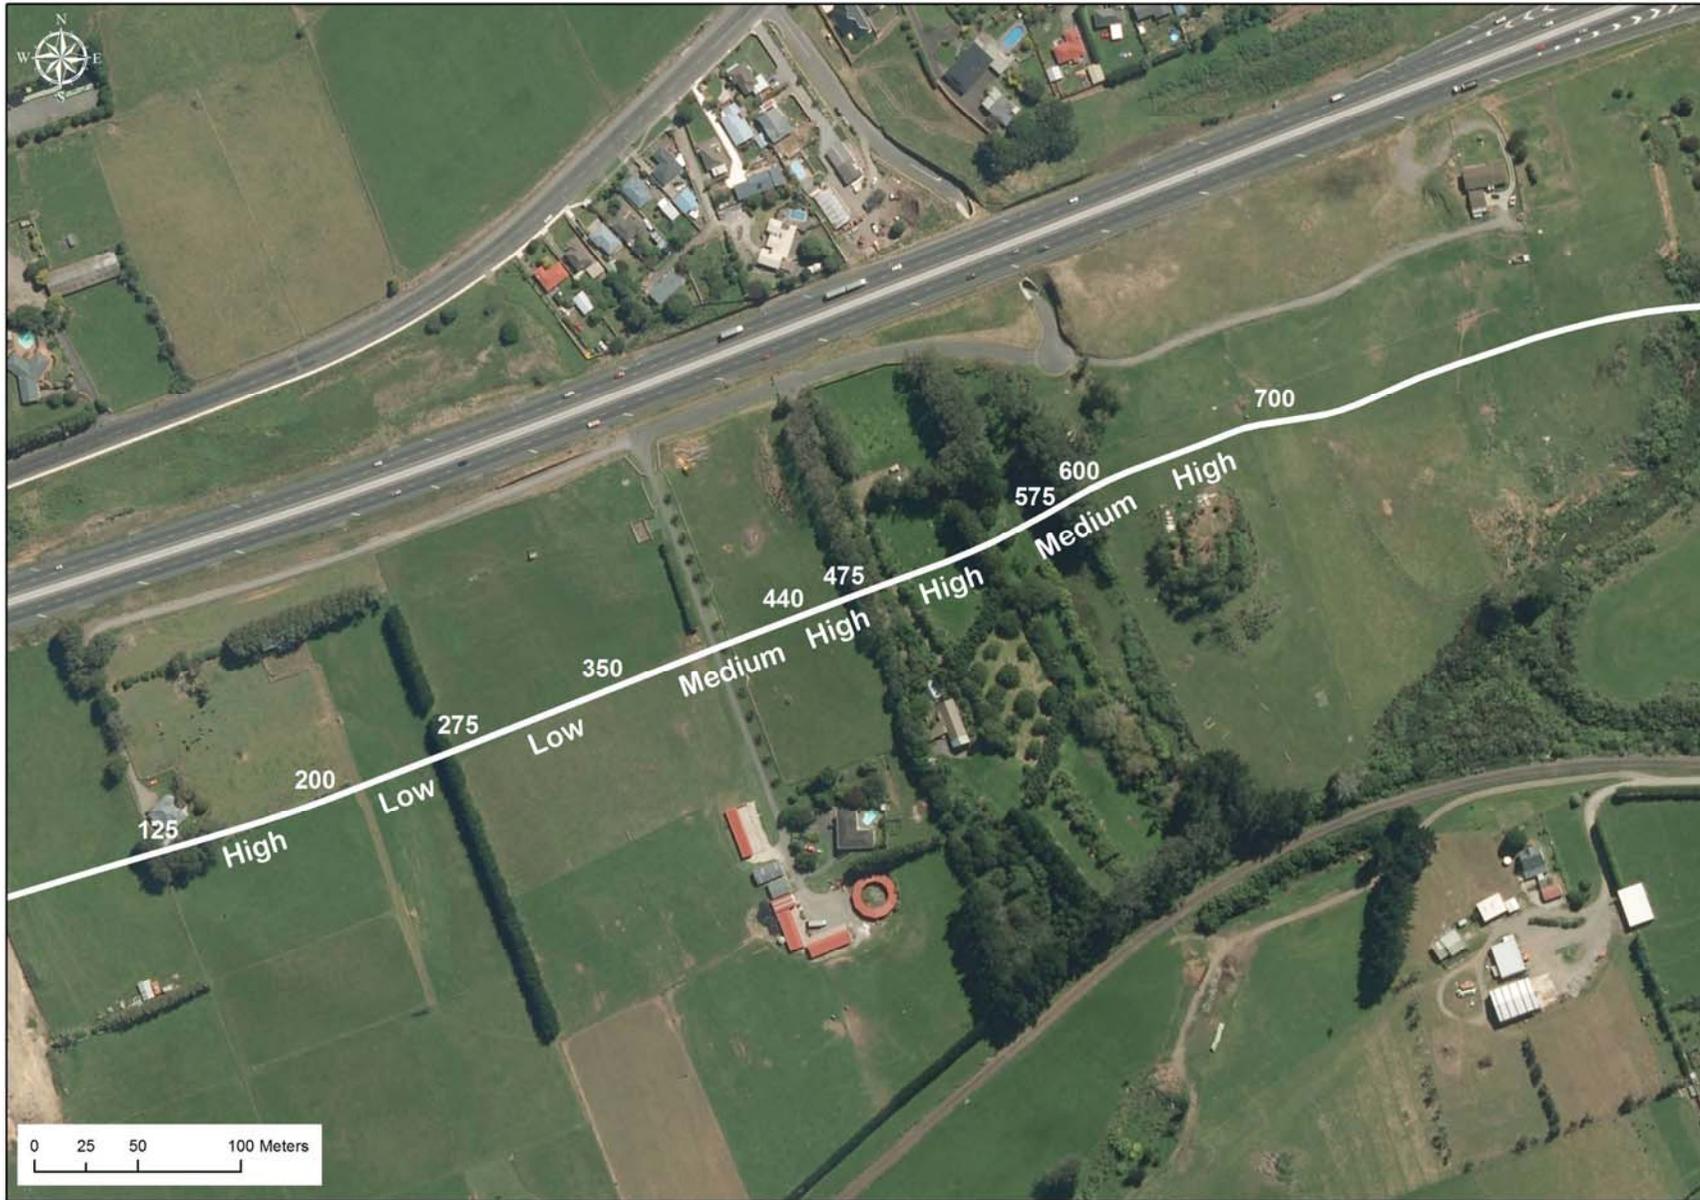
Figure 4: Distance in metres along the Central Alignment showing level of risk. Refer Table 2 for estimated archaeological cost per section.

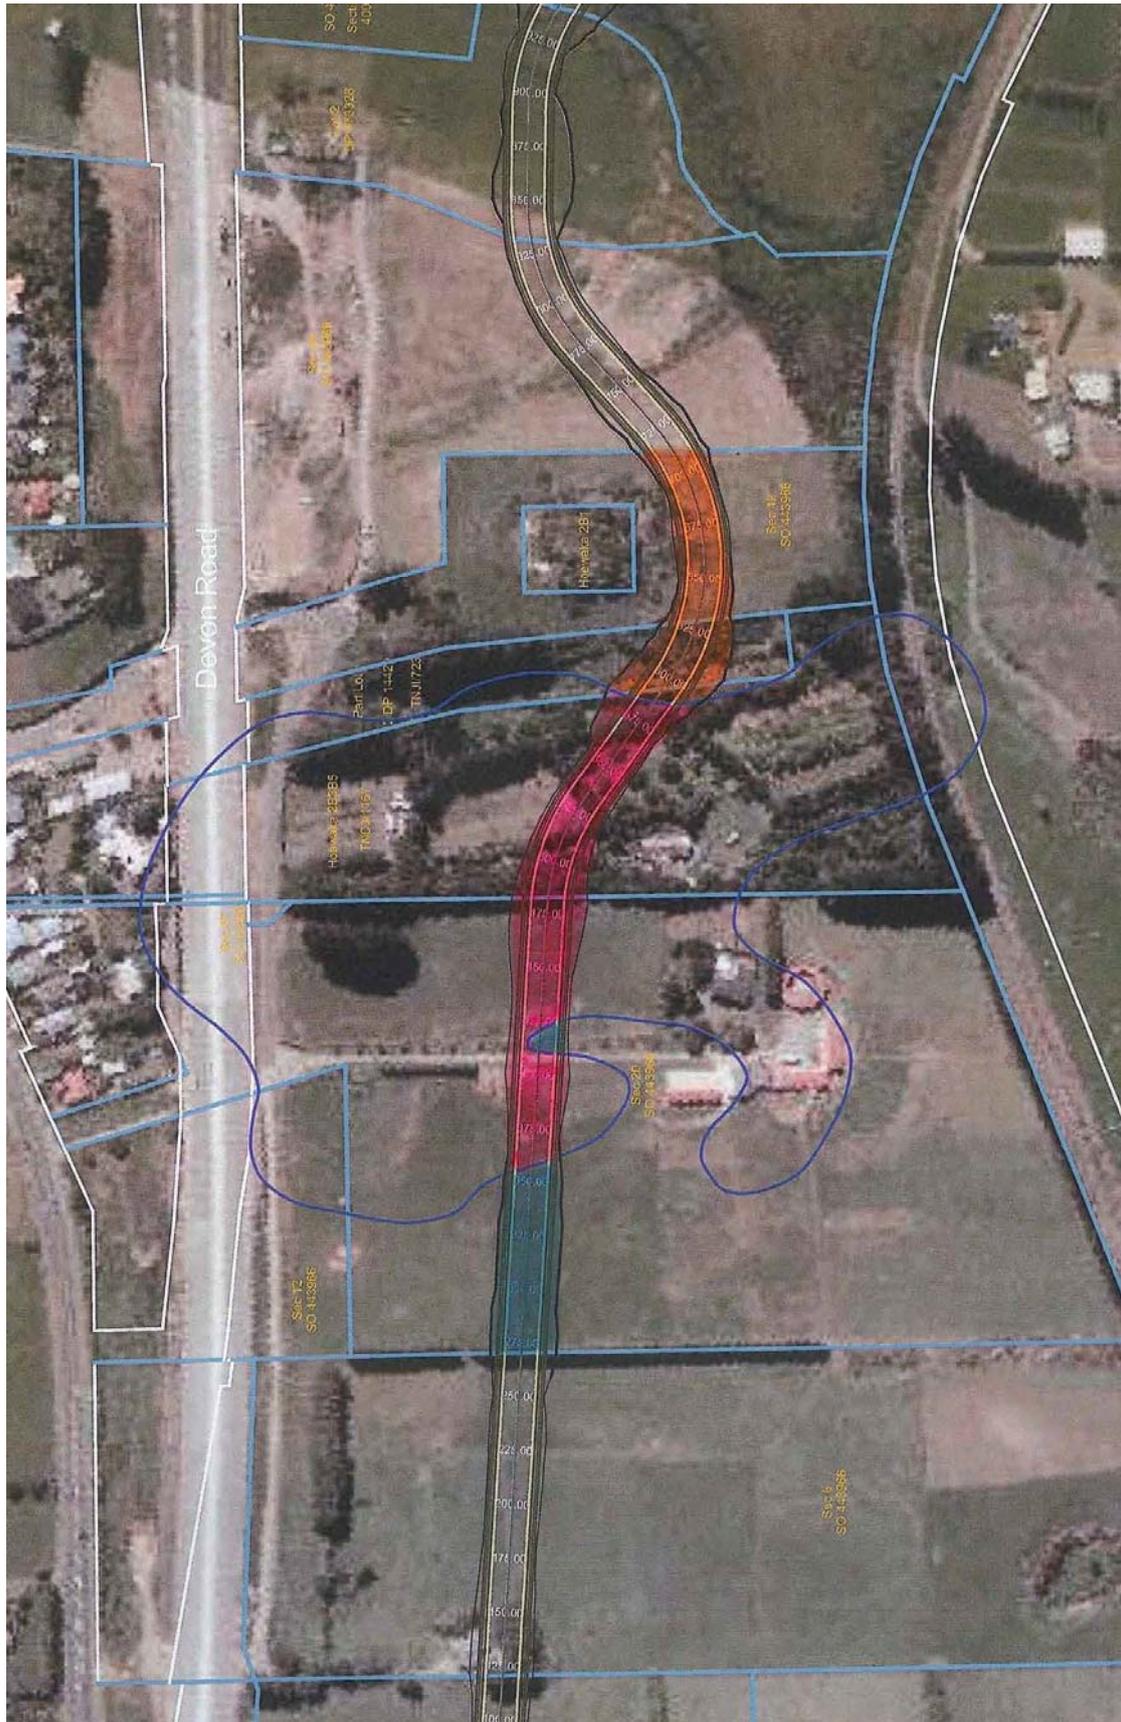
Figure 5: The Alternate Central Alignment route.

The Alternate Central Alignment (Figure 5) poses similar risk and archaeological potential (Figure 6) to the Central Alignment, being almost an almost identical route. However, the dip around the south of Hoewaka/Ngahinapouri appears slightly more risky given its close proximity to site and a number of ephemeral features that lie immediately outside of the fenced urupa, and which are likely to be archaeological. This area carries a lot of uncertainty as it has never been archaeologically tested and, as mentioned previously, the fenced area of Hoewaka/Ngahinapouri represents the delineation of the site proximate to the legal cadastral boundary but does not truly represent the true geographical extent of the original pa.

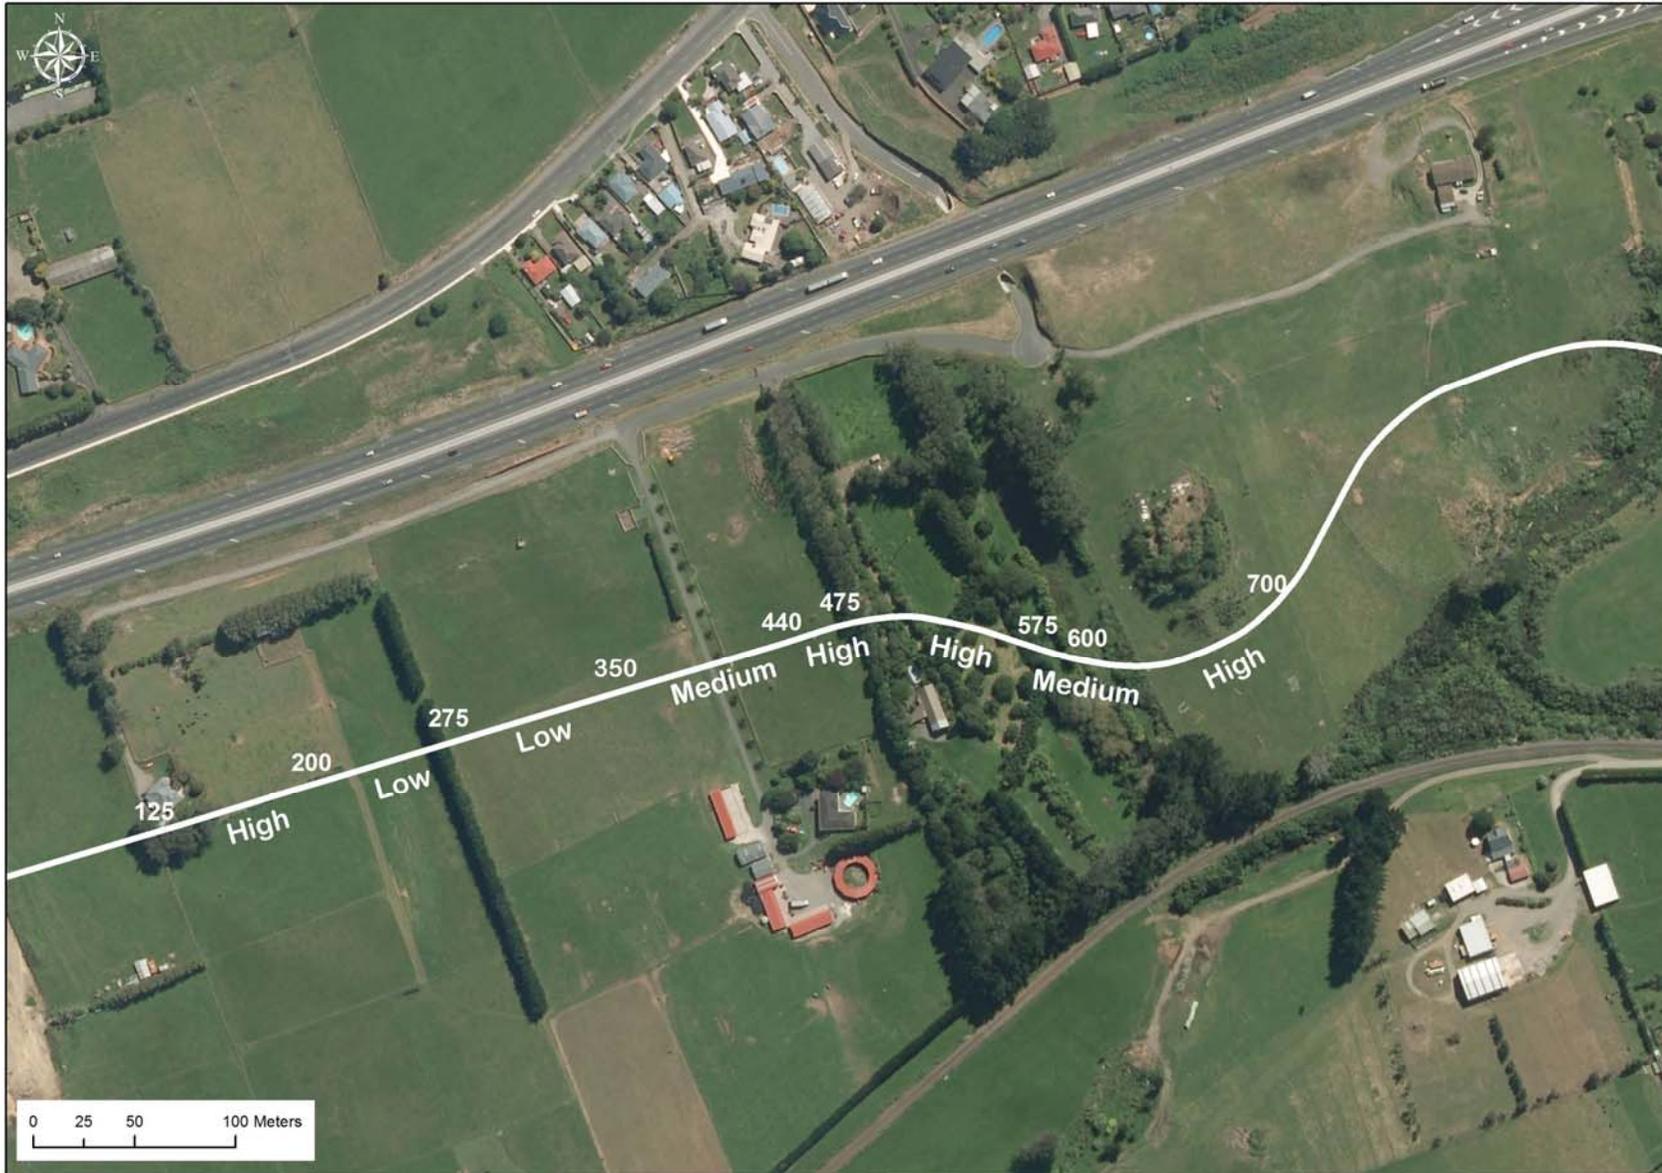
Figure 6: Distance in metres along the Alternate Central Alignment showing level of risk. Refer to Table 3 for estimated archaeological cost per section.

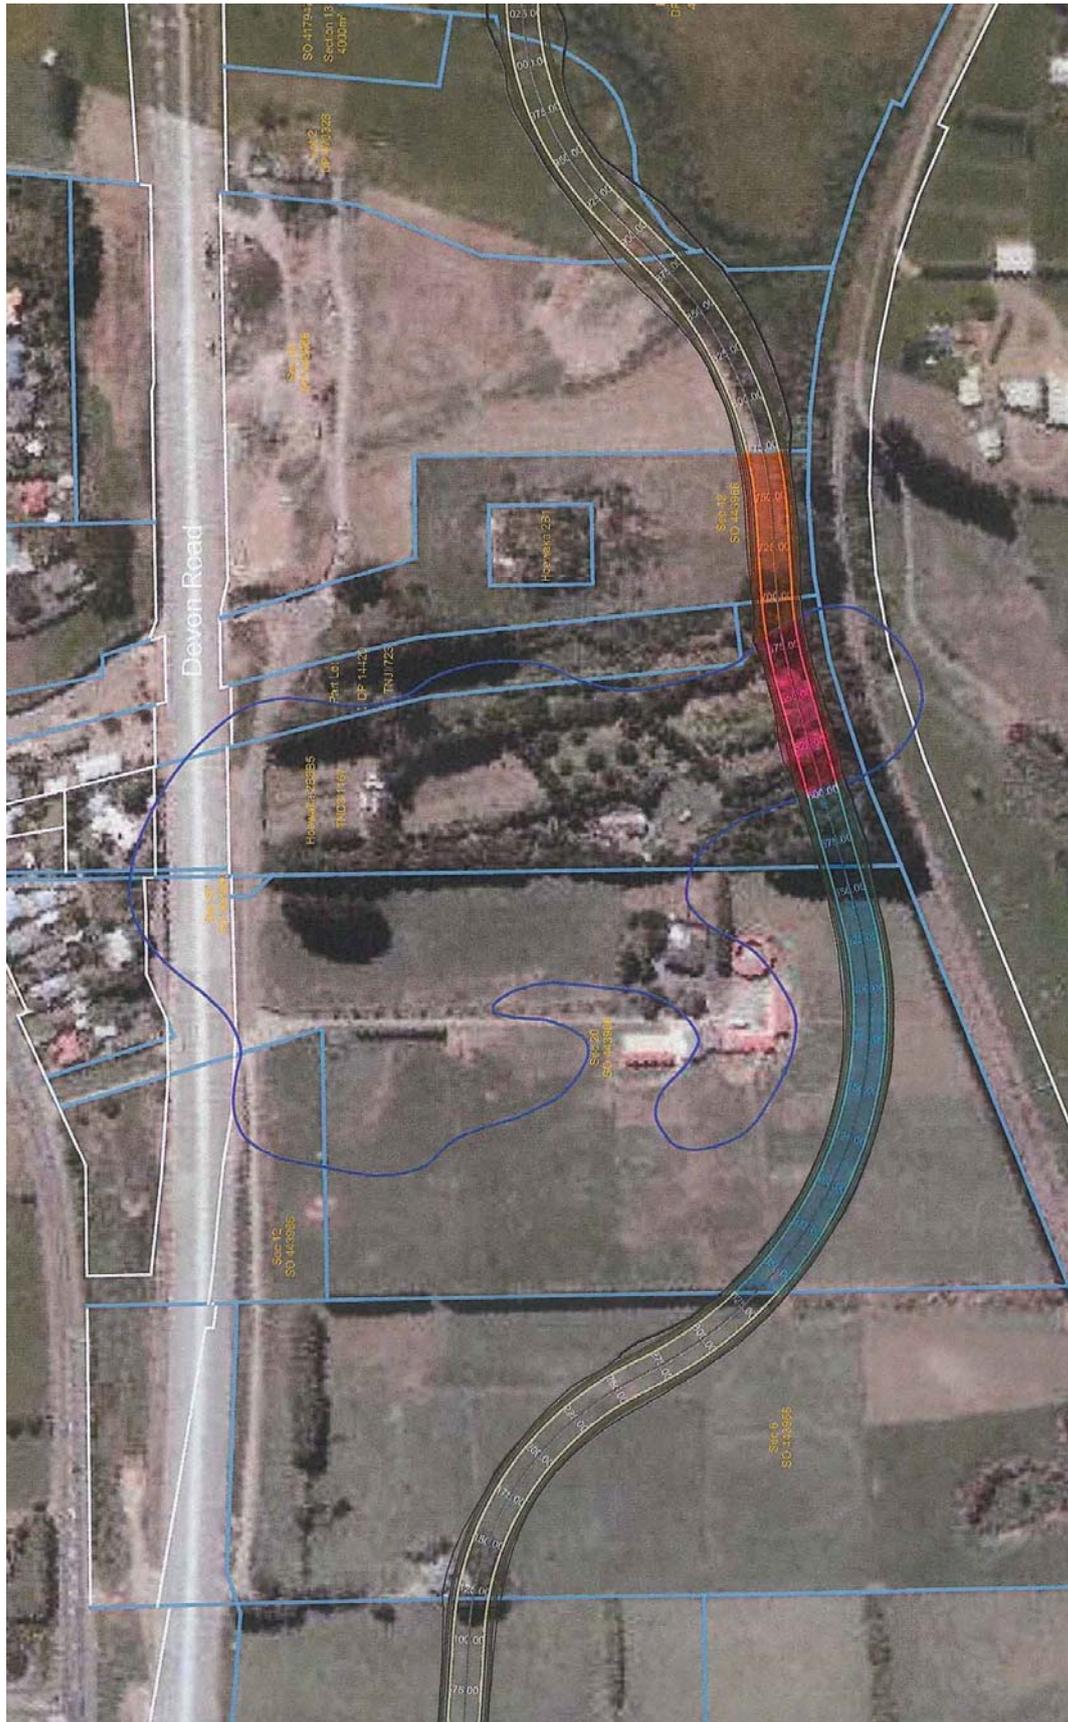
Figure 7: The Southern Alignment route.

The Southern Alignment (Figure 7) represents the least archaeological risk and subsequently is the cheapest option with regards the potential archaeological mitigation required. Risk is greatly reduced due to the siting of the alignment further away from the known extent of Te Oropuriri and away from the hillock where Hoewaka/Ngahinapouri sits. As such, it is anticipated that any archaeological features encountered along this alignment would be of a low density.

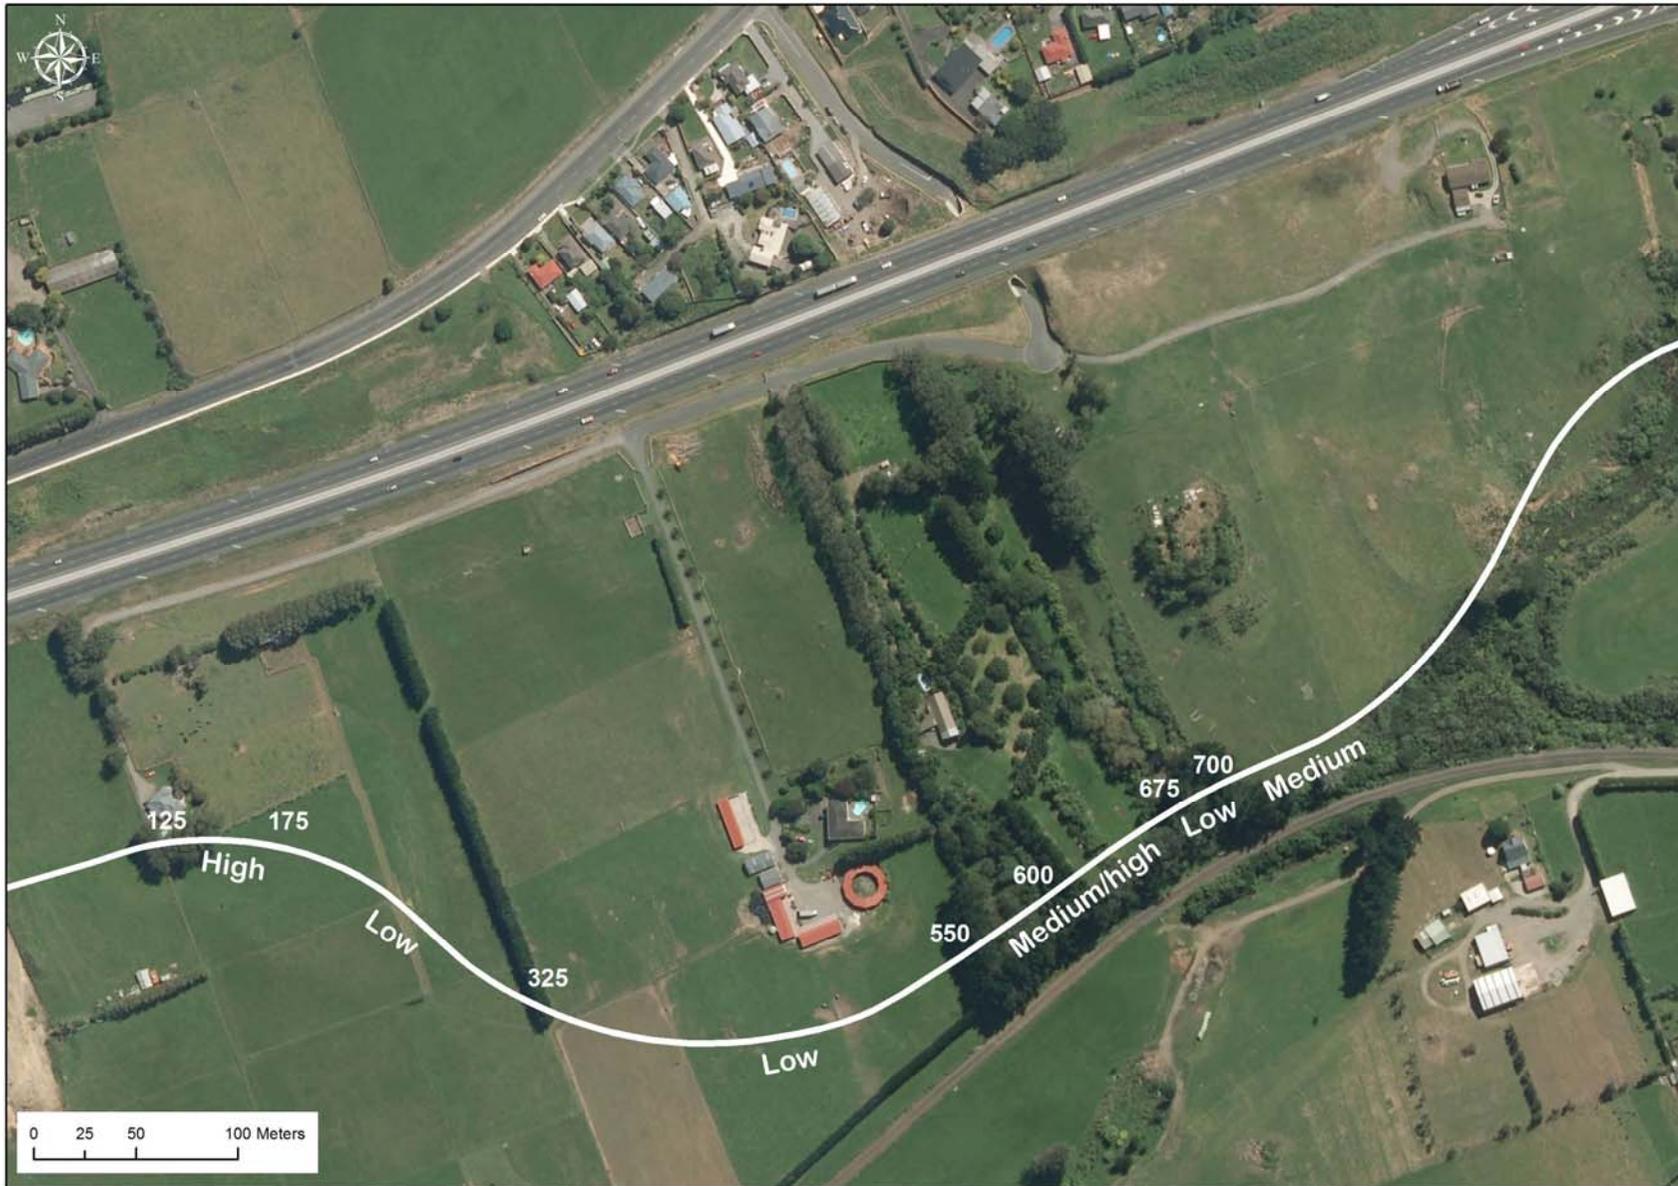
Figure 8: Distance in metres along the Southern Alignment showing level of risk. Refer to Table 4 for estimated archaeological cost per section

Archaeological risk (Figure 8) is greatest as the alignment passes across the southern perimeter of the Caskey and Rowe properties and below Hoewaka/Ngahinapouri. There is some possibility that defensive features associated with Te Oropuriri may be found here on the Caskey and Rowe properties, although the railway corridor and batter would likely have impacted upon these if they actually did once exist.
