**New Plymouth
District Council**

STRATEGIC PROJECTS COMMITTEE MEETING AGENDA

STRATEGIC PROJECTS DEEP DIVE REPORT – INGLEWOOD DISCOLOURED WATER

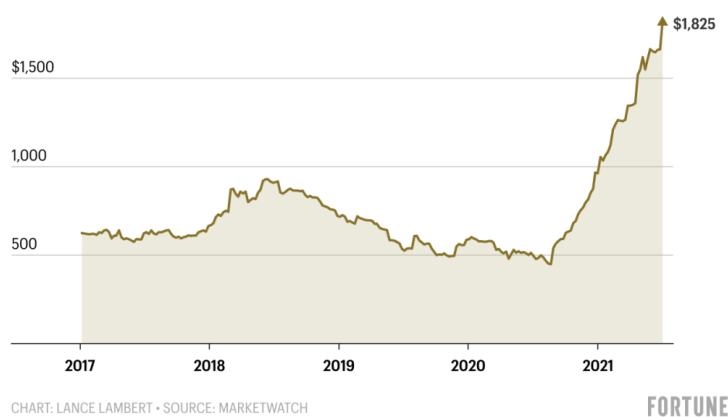
Figure 2 – benchmark price for hot-rolled steel

8. Whilst the headline PPI inflation figure is 6.1%, there are a number of commodity and material prices that have increased significantly higher. These are summarised in figure 2 and the bullet points below¹:

- Fuel and oil FPIQ index has increased by 29.7%
- Raw steel prices increased by 215%
- 40ft sea shipping containers from china to Auckland have increase by more than 350%
- Aluminium increased 62%
- Copper increased 89%
- Concrete increased 18%

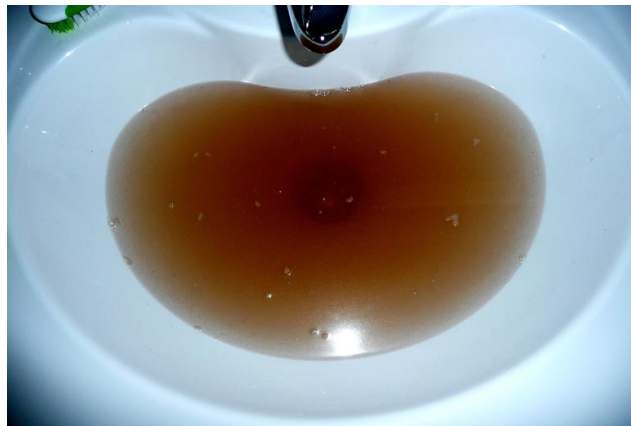
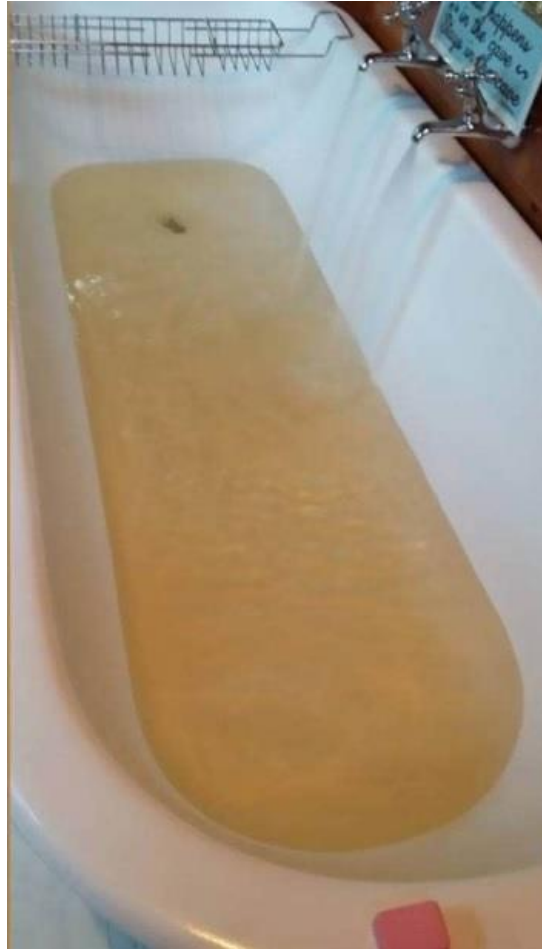
Figure 1

16. Water discolouration is most pronounced when large volumes of water are drawn off from the system which increases the velocity of the water inside the pipes. Higher velocities scours any deposited minerals or biofilm from the inside of the pipes, flushing them from the reticulation system as water discoloured a yellowy-brown colour.

17. Samples of water taken and tested during these discoloured water events have shown elevated levels of aluminium, manganese, iron, lead and copper. Iron and manganese are frequently associated with discoloured water complaints. Manganese in particular can cause staining of laundry, where issues are exacerbated by the use of oxidising cleaning products.

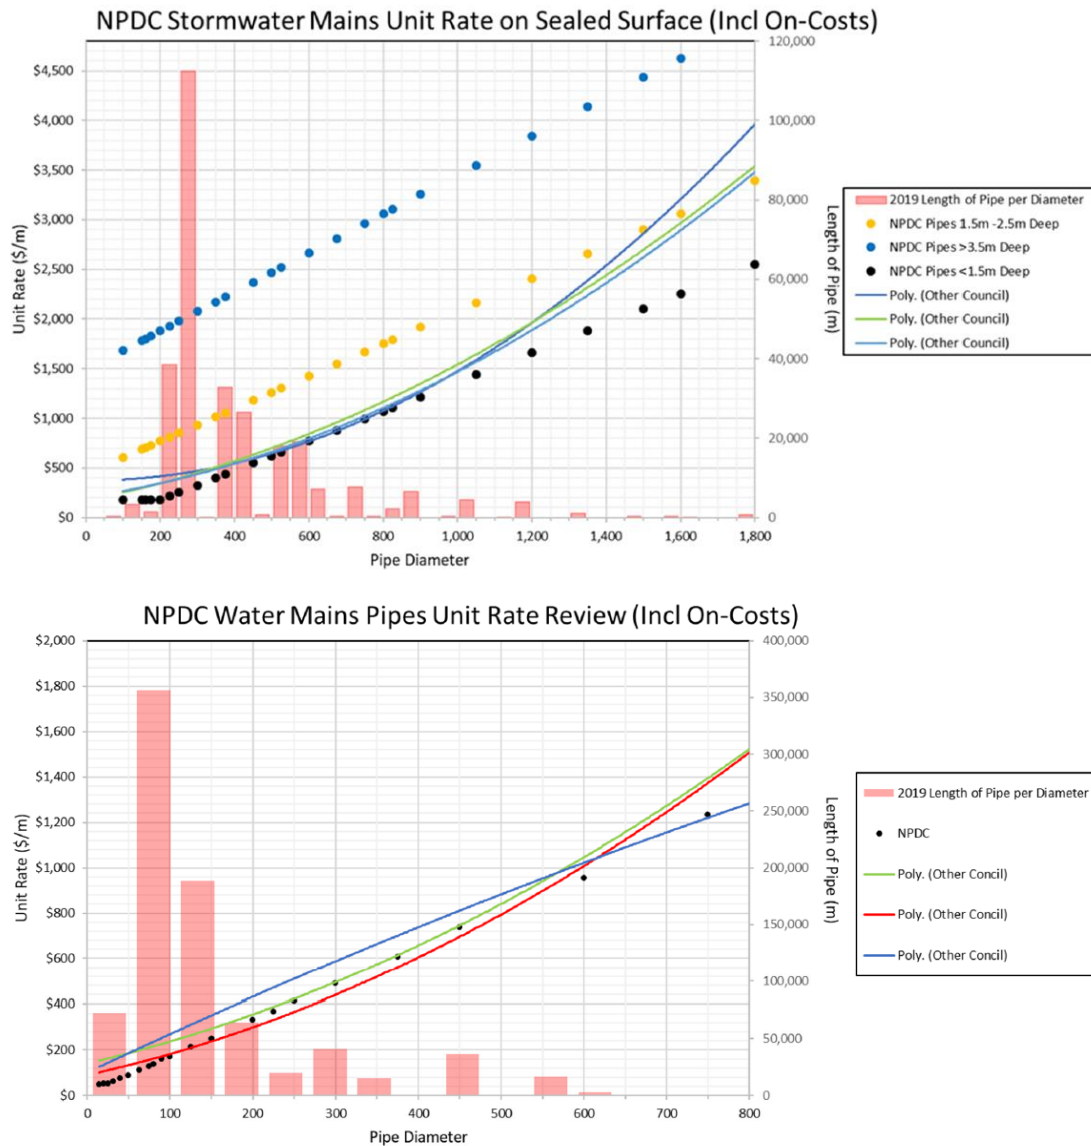
76. When preparing the council's asset valuations the unit rates used for wastewater and storm water pipes are banded based on a range of pipe installation depths. Figure 7 illustrates the range of unit rates for storm water pipes based on their diameter and installation depths. This figure also shows the range of unit rates for water pipes based solely on the pipe diameter.
-

77. The council's asset management system currently does not record the depth of the majority of its drinking water pipes. In the absence of this data set, the asset valuation makes the assumption that drinking water pipes are installed at an average depth of 1.15m. This assumption is very close to the minimum installation depth required by the NZS 4404 Subdivision infrastructure standard of 1.08m.
