# State Highway 45 Post Construction Safe System Audit

Transport Choices – Barrett Road to Morley Street

Prepared for New Plymouth District Council  
Prepared by Beca Limited

23 July 2025

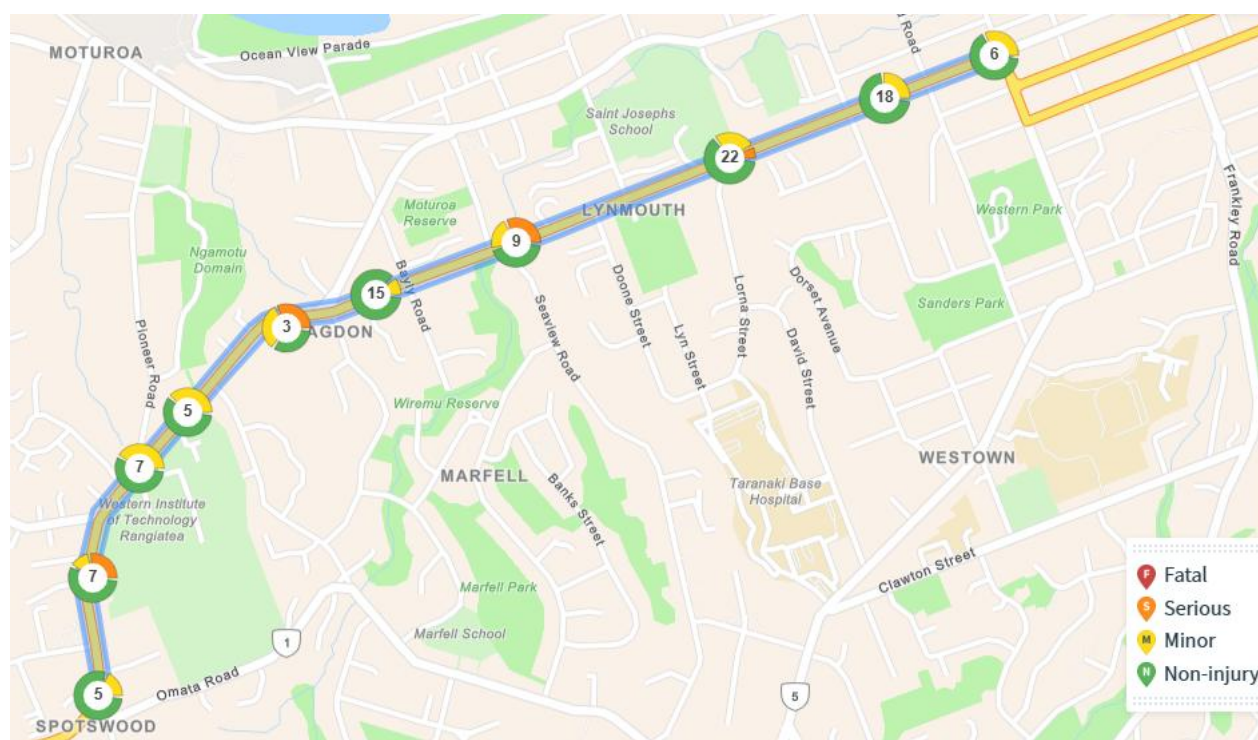
Figure 1-2: CAS Analysis Map of the State Highway 45 Corridor

A search of the New Zealand Transport Agency Waka Kotahi (NZTA) crash analysis system (CAS) has been undertaken for a period between June 1<sup>st</sup> 2020 and June 1<sup>st</sup> 2025. **Figure 1-2** below outlines the extent of the CAS search along State Highway 45 - Devon Street West and South Road, and the locations of the reported crashes. In the above time period, there were 97 recorded crashes, described below.

The crashes highlighted above in **Figure 1-2** have been grouped based on the severity of injuries sustained by those involved. Provided below is a detailed summary of the serious crashes, followed by a high-level overview of minor and non-injury crashes, particularly regarding their location (Mid-block or Intersection) and whether or not active users were involved.

Following the installation of the cycle way separators there is no evidence within the CAS database that suggests that there has been an increase in crashes throughout the corridor. It is noted by the SAT that there have been some incidents anecdotally on the corridor since the project was constructed, however, the minor and non-injury crashes are unlikely to have been uploaded to the CAS database at the time of preparing this SSA.

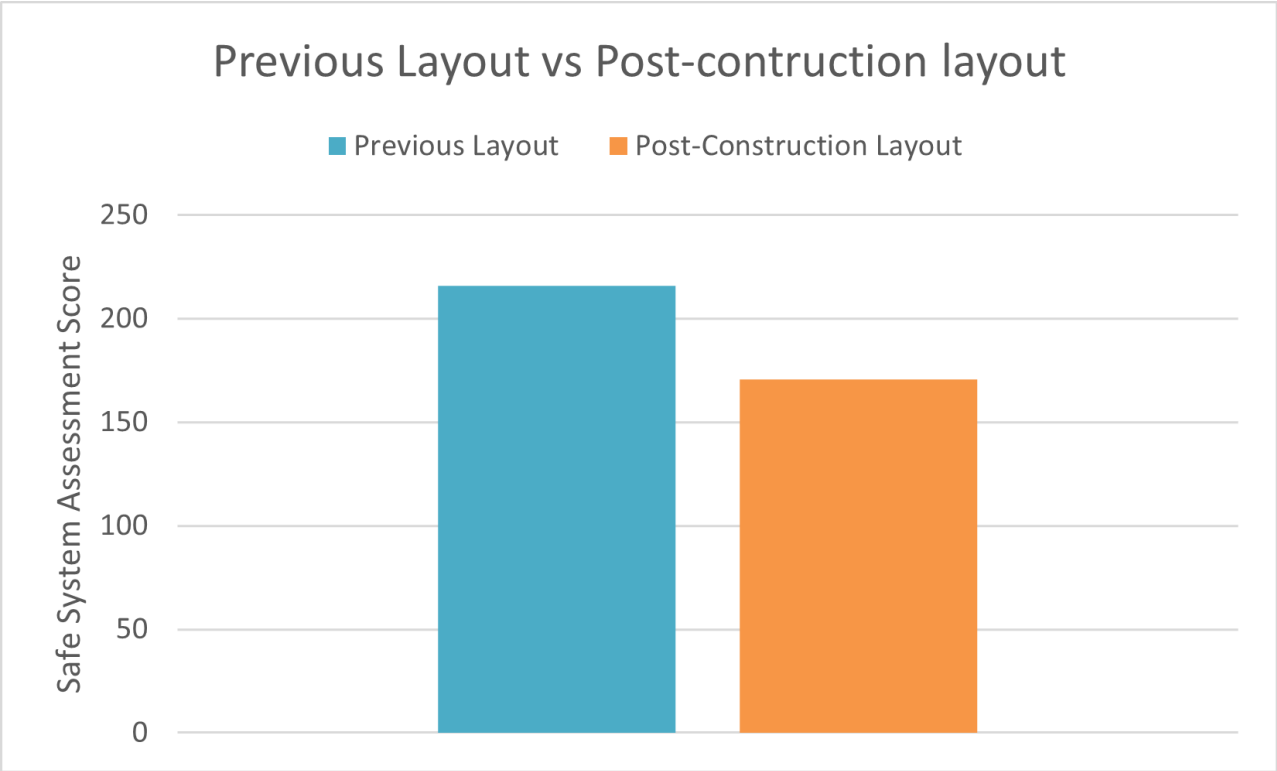
Figure 3-1: Previous layout vs Post-construction layout overall safe system scores

A safe system assessment has been undertaken by comparing the transport corridor before and after construction. Overall, the project results in a reduction of the Safe System score, suggesting an improvement in safety on the corridor. The summary of the Safe System Assessment is shown below in **Figure 3-1**.

Motorcyclists were identified as the most at-risk road users throughout the corridor, this is predominately due to their exposure score, scoring a total of 48, which has not been affected by the project. Pedestrians and cyclists scored second highest equal with a previous layout score of 36, following the installation of the road upgrades pedestrians scores reduced to 24 and cyclists reduced to 15.75.

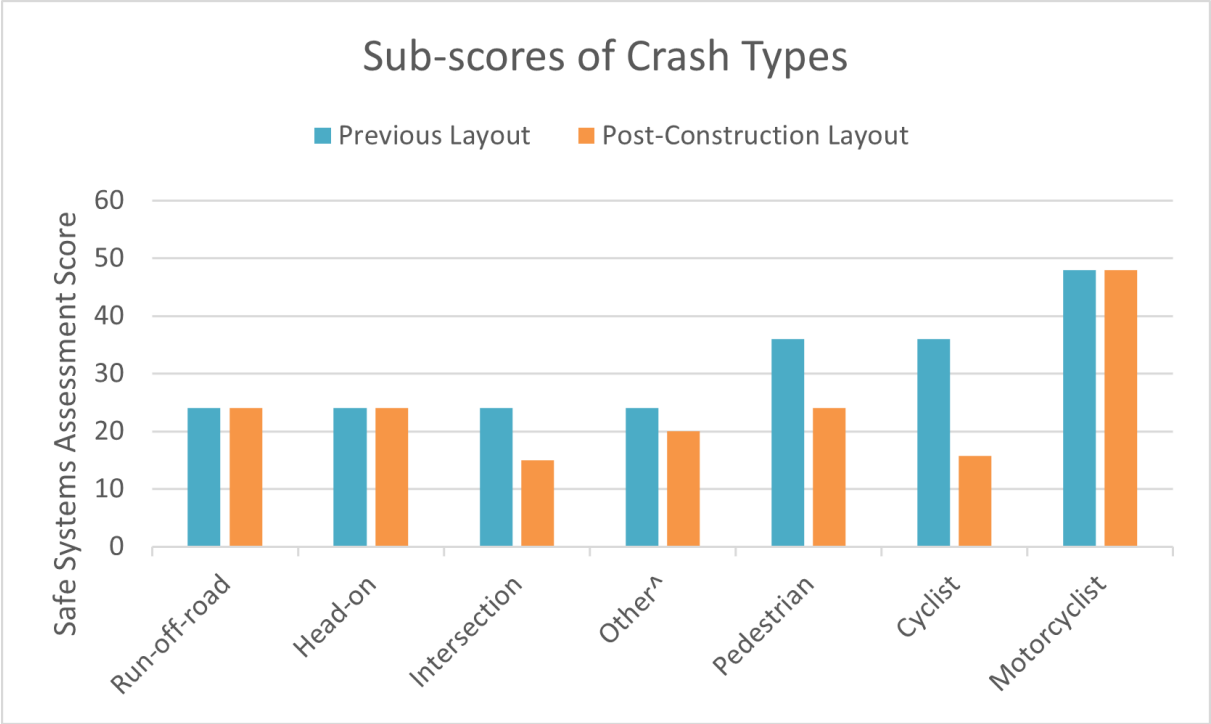
Figure 3-2: Safety system assessment summary by crash type

A summary of the safe system assessment scores per crash type is shown below In **Figure 3-2**.

Prior to the walking and cycling upgrades, the corridor lacked pedestrian crossing infrastructure at many key desire lines, particularly at intersection approaches from minor roads. With the upgrades, several intersections now feature pedestrian refuge islands and kerb build-outs. These additions shorten crossing distances and allow pedestrians to cross in stages, making it safer by reducing their exposure to oncoming vehicles.

The previous corridor layout did not prioritise cyclist safety, exposing them to a higher risk of side-swipe and rear-end crashes. This was largely due to narrow cycle lanes and poor road conditions that reduced the usable space for cyclists. With the recent upgrades, cyclists now have separation from live traffic lanes along most of the corridor. This has significantly improved safety by protecting the rideable space.
