2 Johnston St, Waitara

Preliminary Site Investigation

For Hareb Investments Ltd

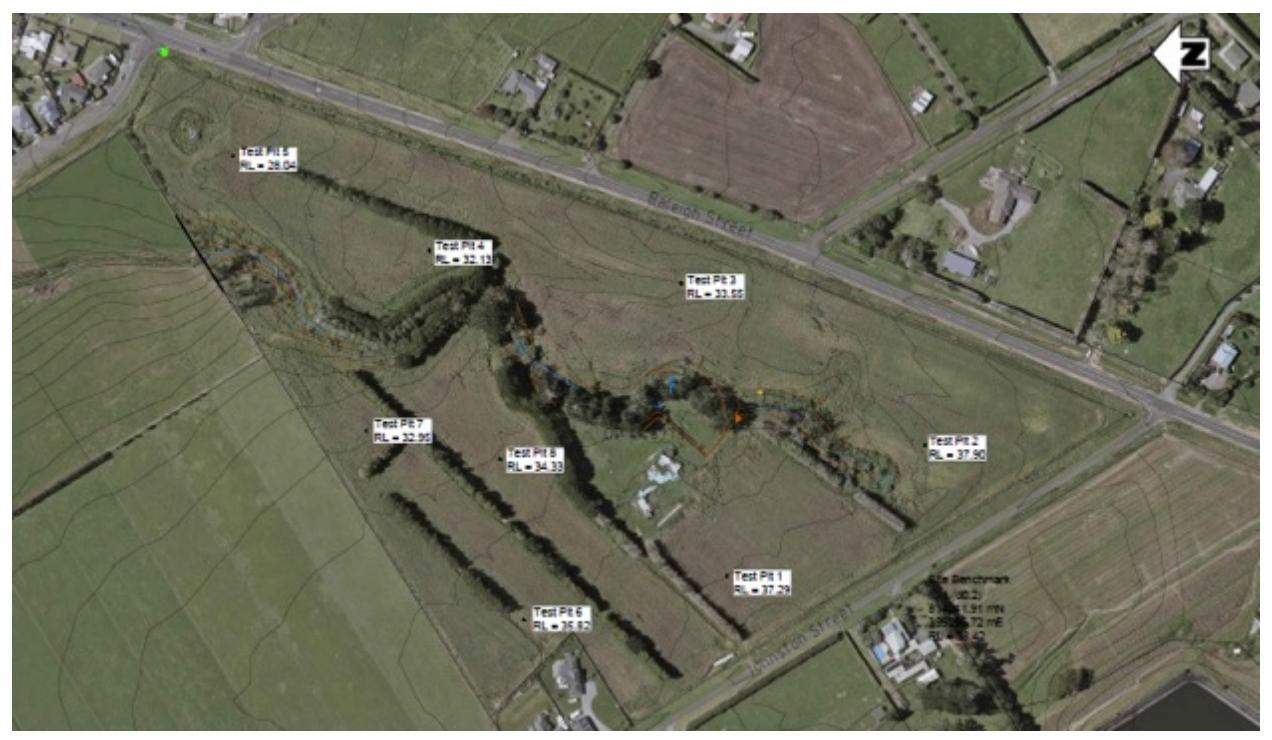
2 mbgl. This location is in the eastern part of the site, near the intersection of Raleigh and Borthwick Streets (see Figure 5). No fill was identified; and

Figure 5 – Extract from draft hand auger location plan by Civil Infrastructure Consultants Ltd (drawing attached in Attachment A). Note that the reference to "test pits" is erroneous – we understand that all investigation locations were hand augers.

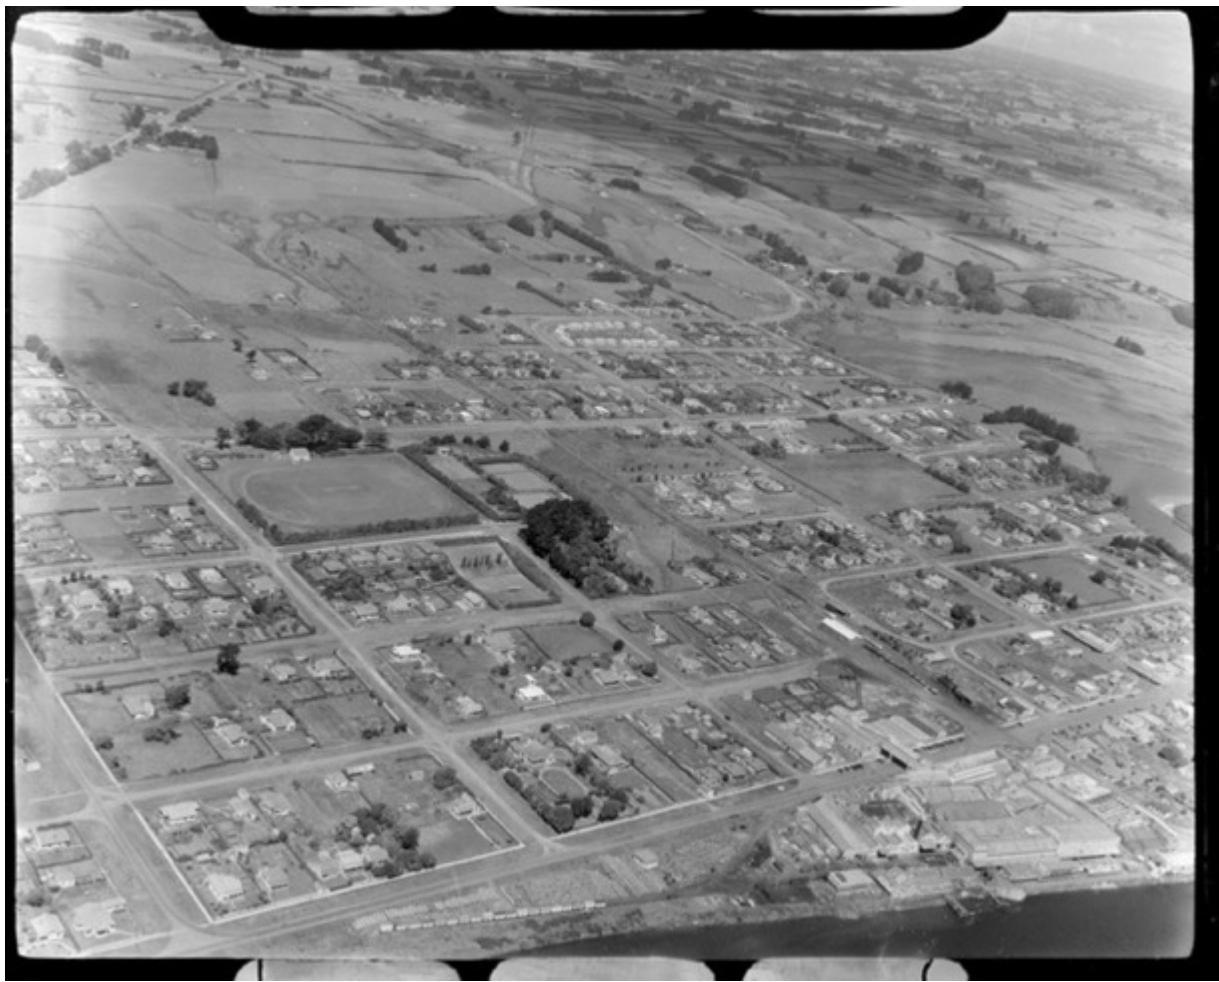
Figure 6 – 1947 aerial photo, showing part of the site near the top left corner. (Timeframes ref: WA-05583-F)

Although the site is near the edge of the 1947 photo and partially obscured, it appears that at least the visible part of the site was used for pastoral farming at that time.

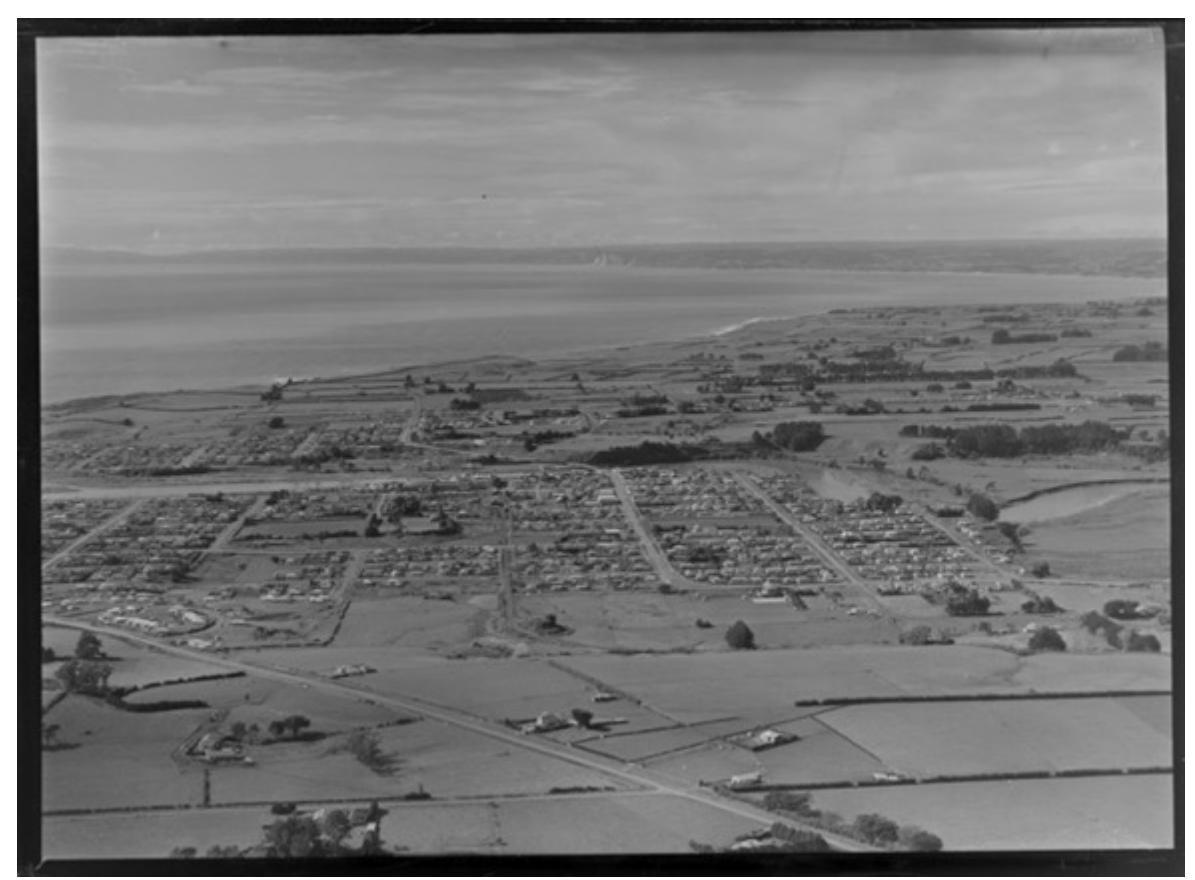
Figure 7 - 1958 aerial photo showing site in left foreground (Timeframes ref: WA-477331-G)

The 1958 aerial photo shows the site much more clearly, and confirms that the site was pastoral farmland or similar at that time. At least two buildings are visible near the centre of the site. It is not clear whether these are the same as the two large sheds near the centre of the site at the time of the 2001 photograph. There is no evidence of a stock yard area around either building.

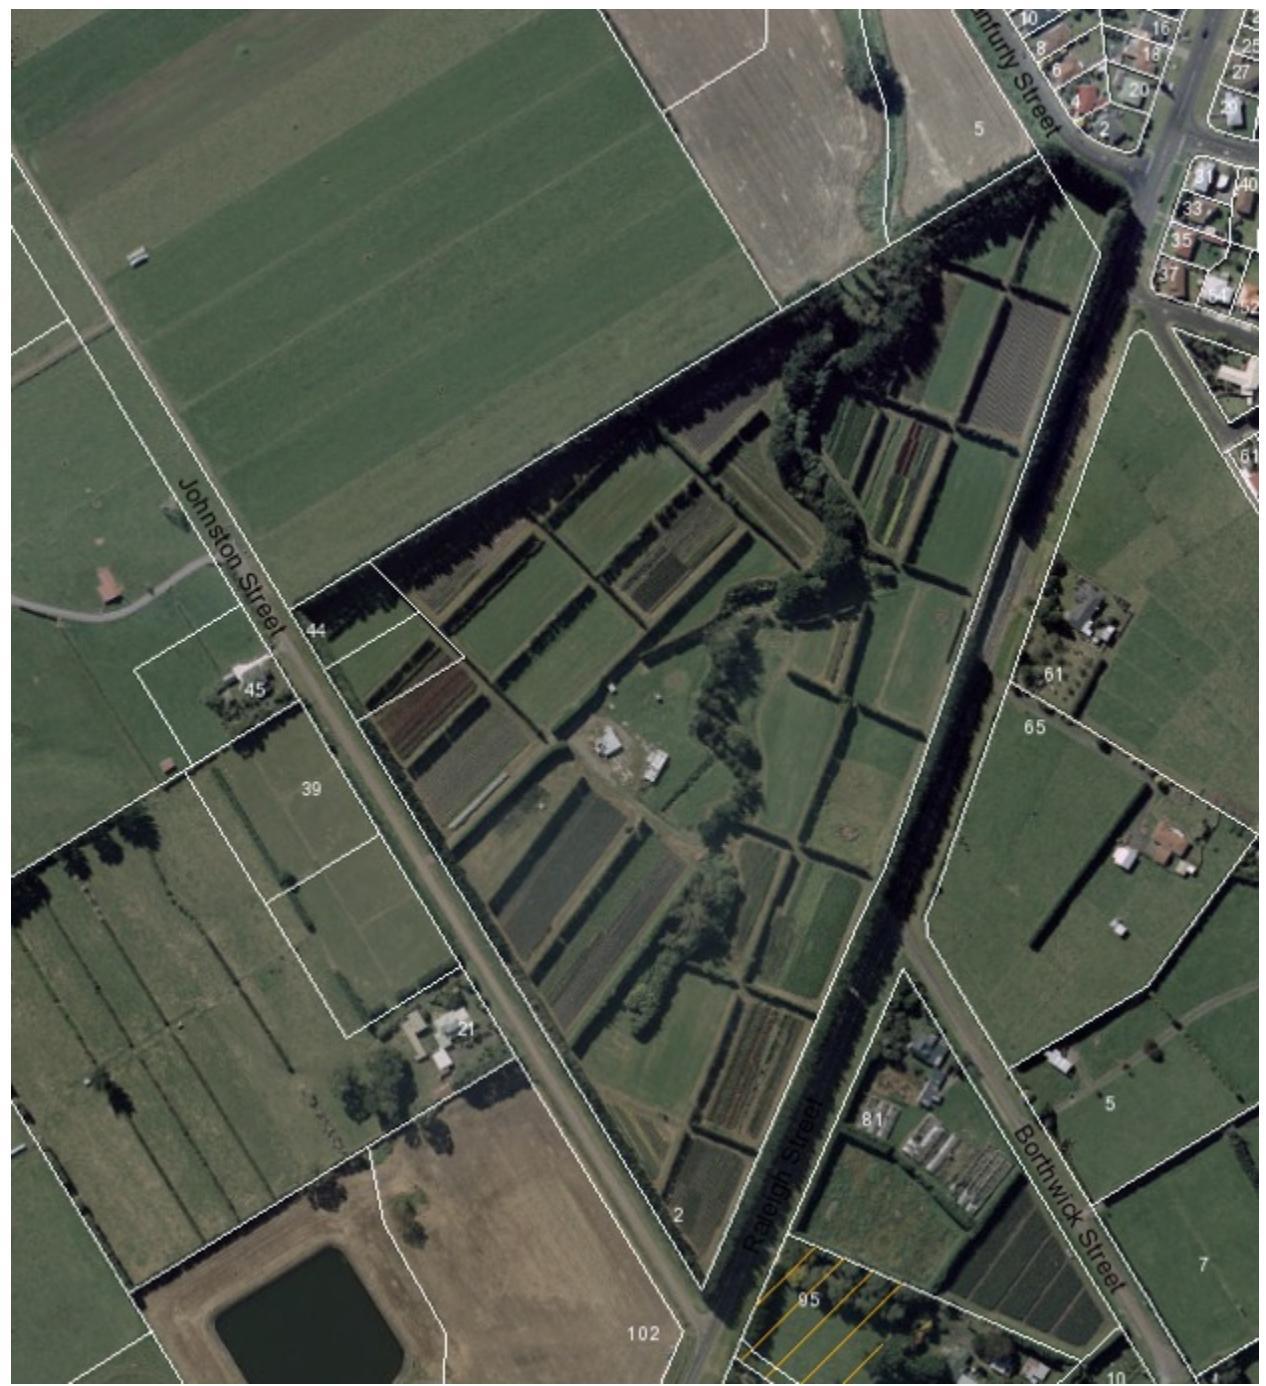
Figure 9 - 2005 aerial photo (NPDC GIS viewer)

The land use in 2005 had not changed significantly since 2001, but 2 of the small sheds had been removed from the southern part of the yard area.

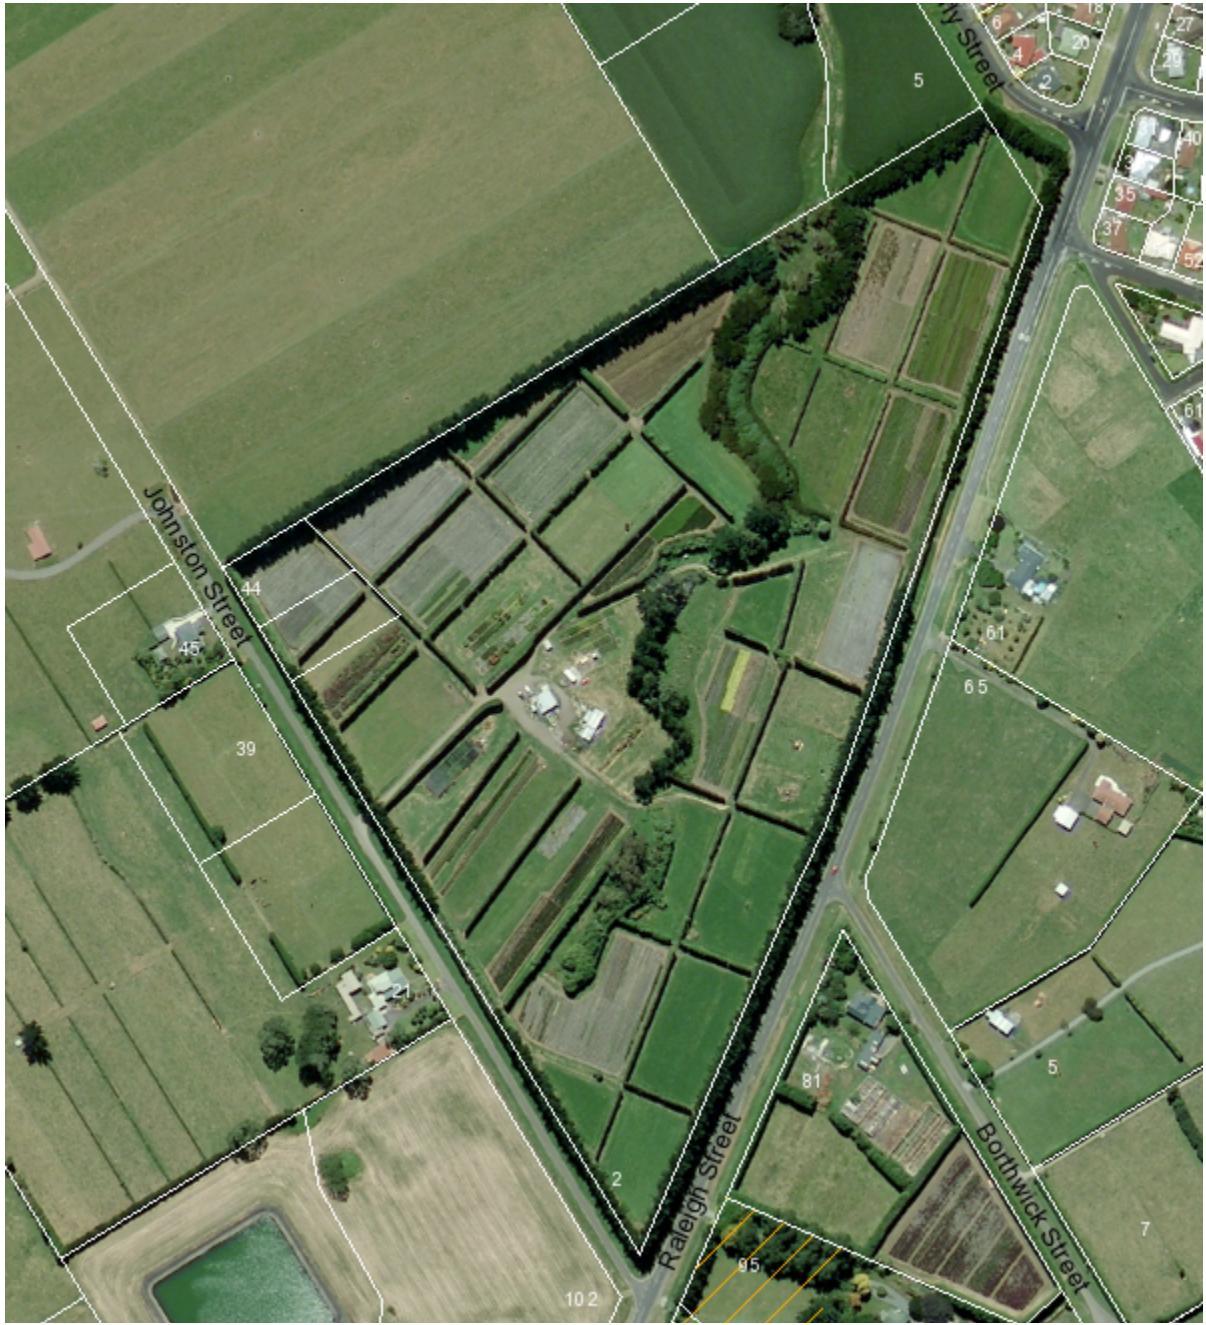
Figure 10 – 2007 aerial photo (NPDC GIS viewer)

By 2007, an additional rectangular feature was present near the centre of the yard area. This was no longer present in the 2010 aerial photograph (not pictured), and may have been a house bus or tent. The market gardening activity also covers less of the site in 2007 than in previous photographs, although this may be due to the season in which the photo was taken. The 2010 aerial photo (not pictured) shows a similar area in horticulture to previous photographs.
