Onaero Beach Walk - 15 February 2018

KEY COASTAL FACTS

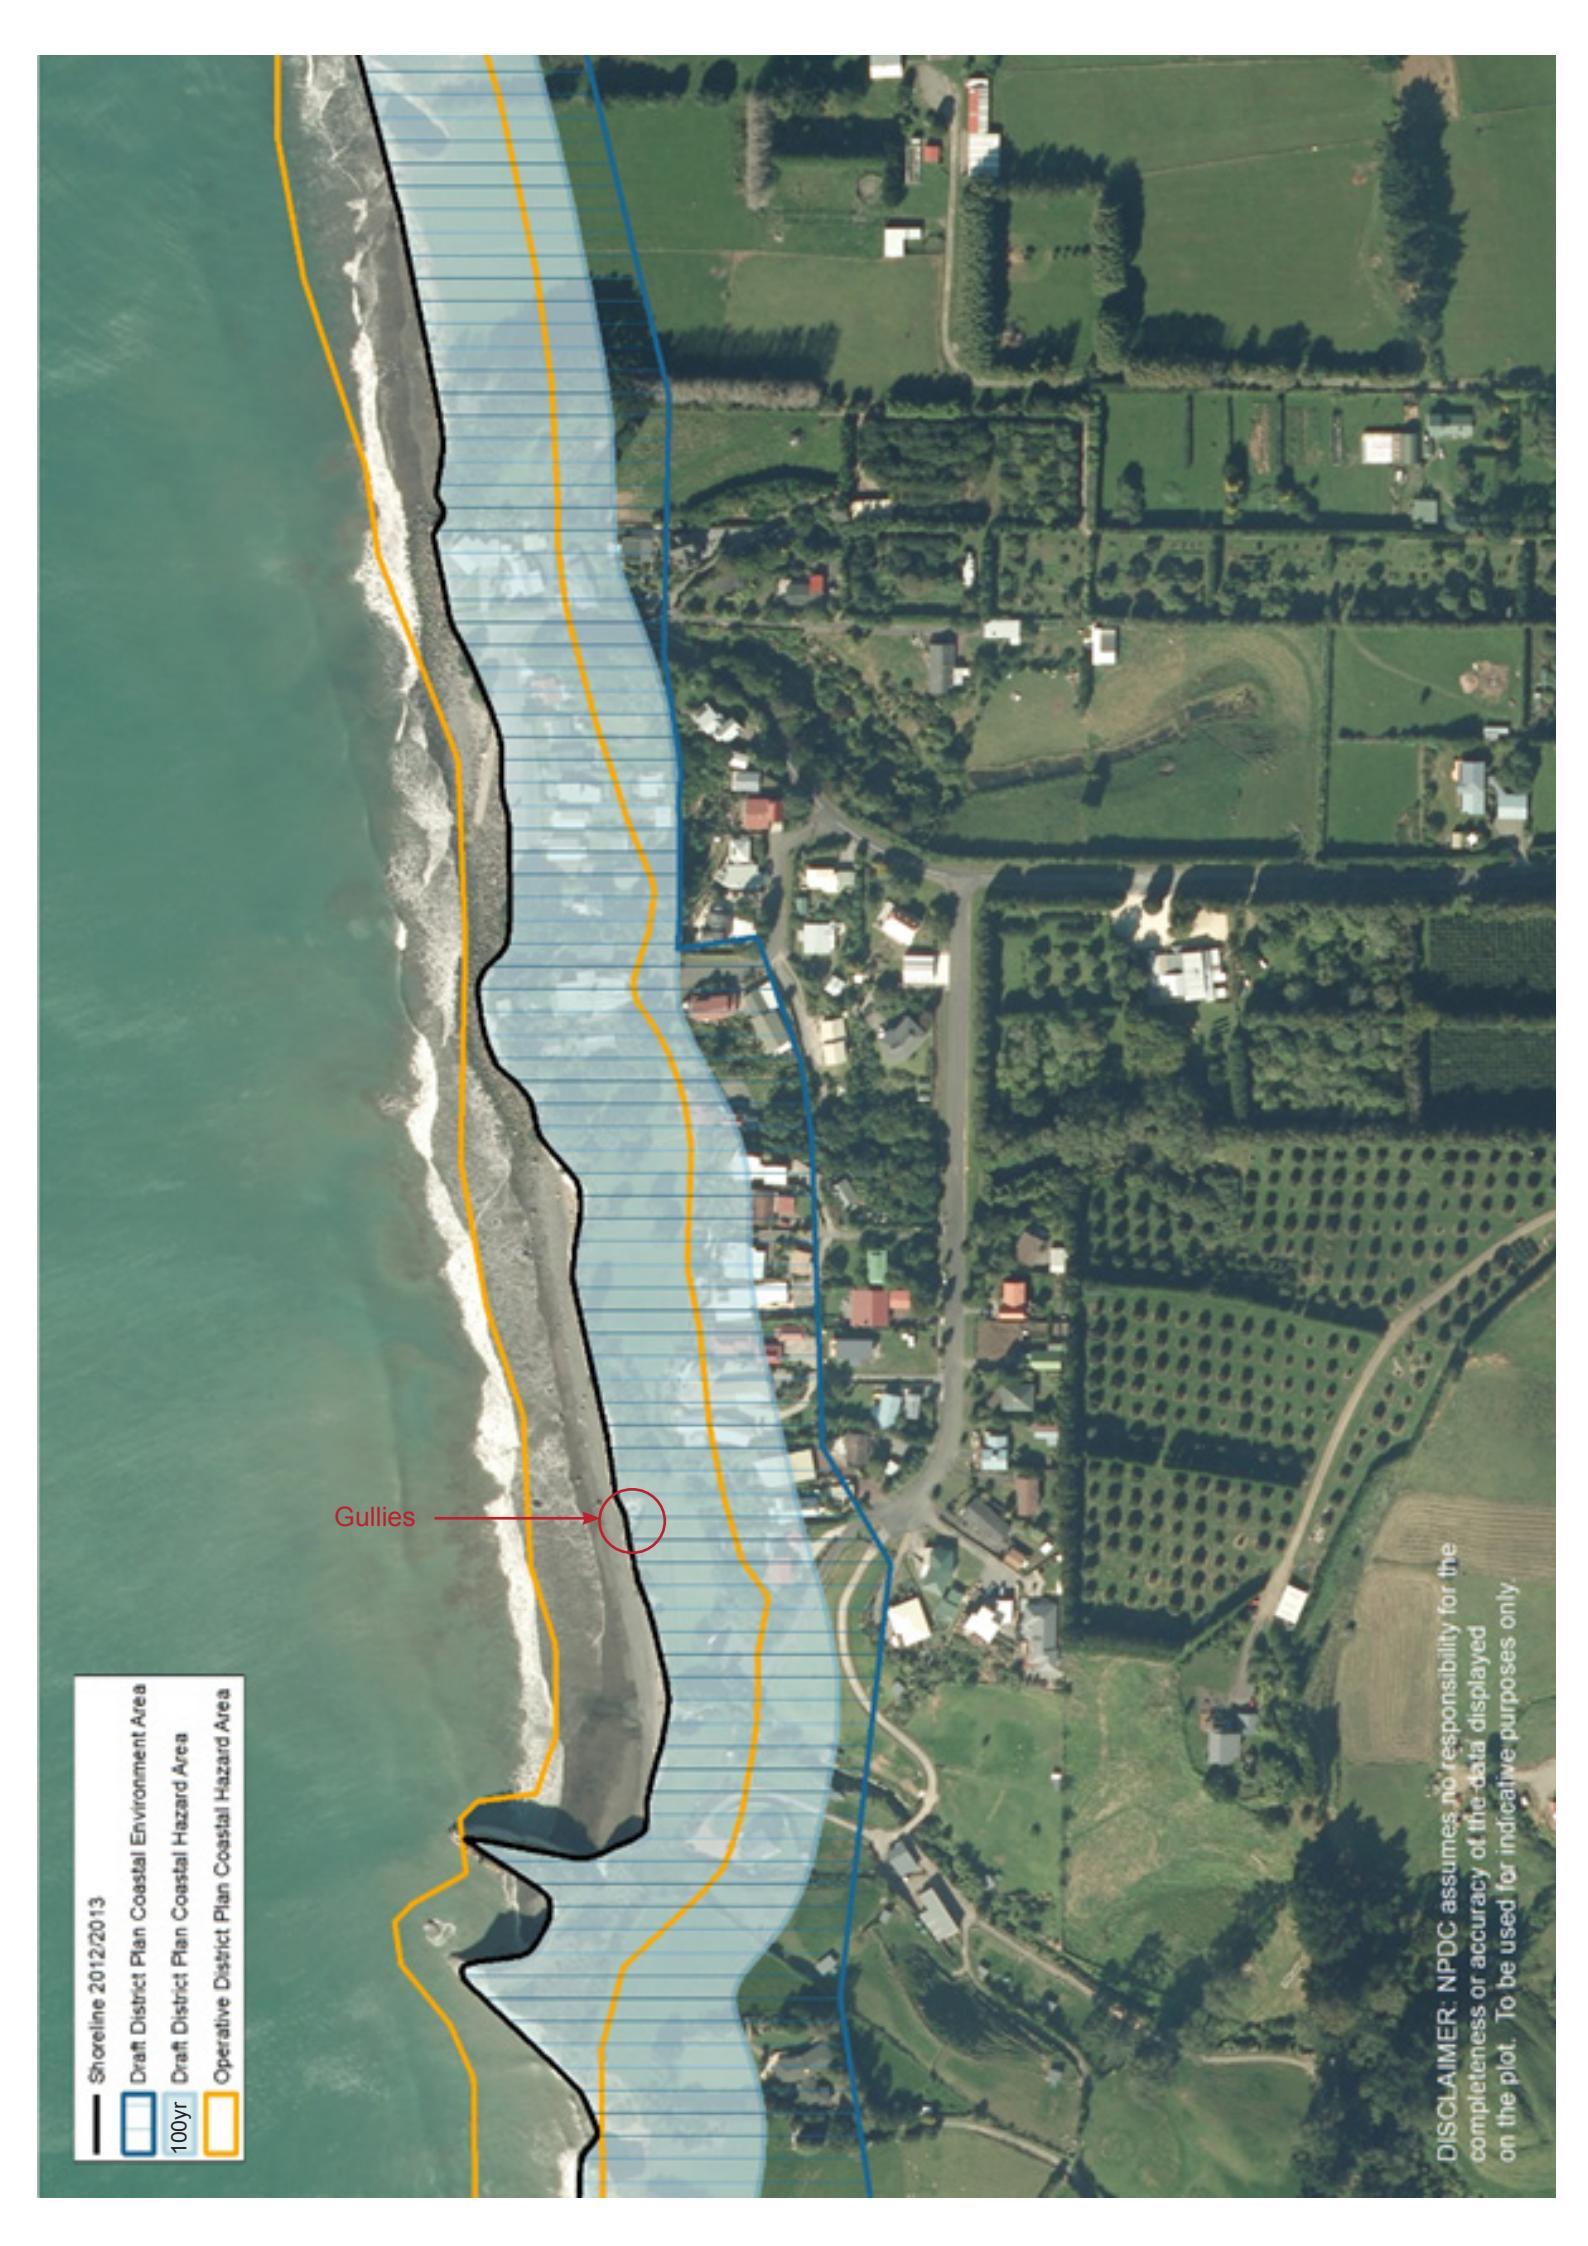
The yellow lines show the coastal hazard area, which was calculated in 1988 and is currently in the Operative District Plan. The seaward extent of the yellow lines shows the distance the coast has eroded since this time.

The blue-shaded zone shows the area that may be affected by erosion and land instability in 100 years if erosion continues at current rates. This zone ignores coastal protection works as they may not be effective over 100 years.

Erosion rates may increase with future climate change and sea level rise. This has not currently been incorporated into the blue-shaded coastal hazard area but is being investigated.

The coastal erosion hazard area includes future erosion of the cliff toe and land areas above that may become unstable.
